**REPORT OF THE ARCHEOLOGICAL INVESTIGATIONS OF THE
NEW CASTLE COURT HOUSE PLAZA (7NC-E-105A)
NEW CASTLE, DELAWARE**

Delaware State Museums

John Milner Associates, Inc.

March 2006

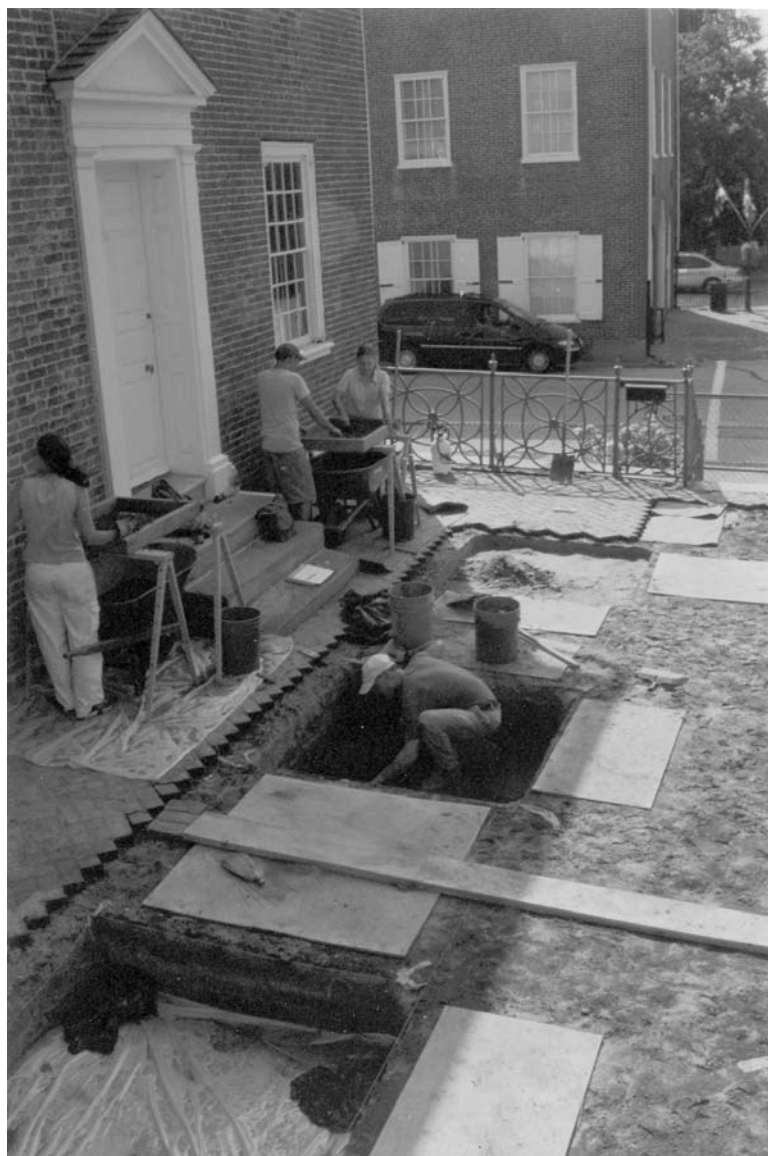
Plate 1. East plaza overview showing the initial excavation of Feature 20 (cellar hole) within EU 8 and the screening of the patio foundation sand from EU 10; view to grid northeast.

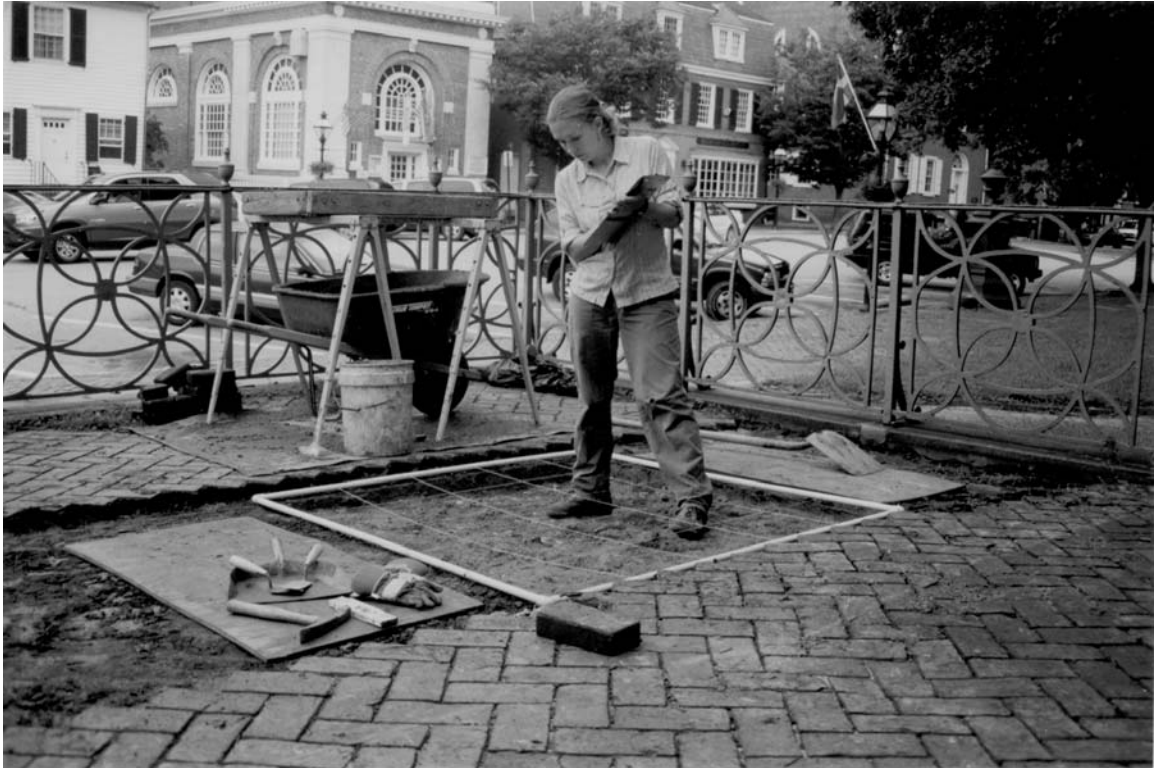
Plate 2. Plan view mapping of EU 21 located on the western plaza; view to grid southwest.

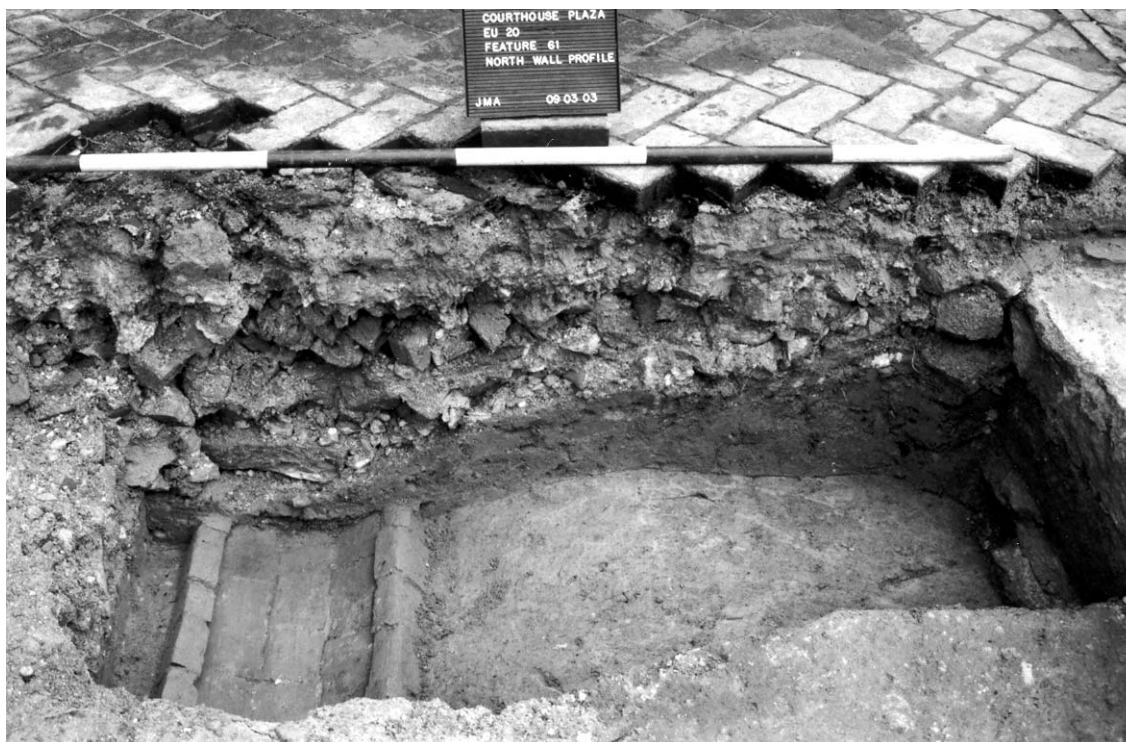
Plate 3. North profile of EU 20 showing the stratigraphic profile within the 1845 plaza extension; the location of a dry laid brick drain (Feature 61) and the edge of the ca. 1820 patio (Feature 21) are shown.

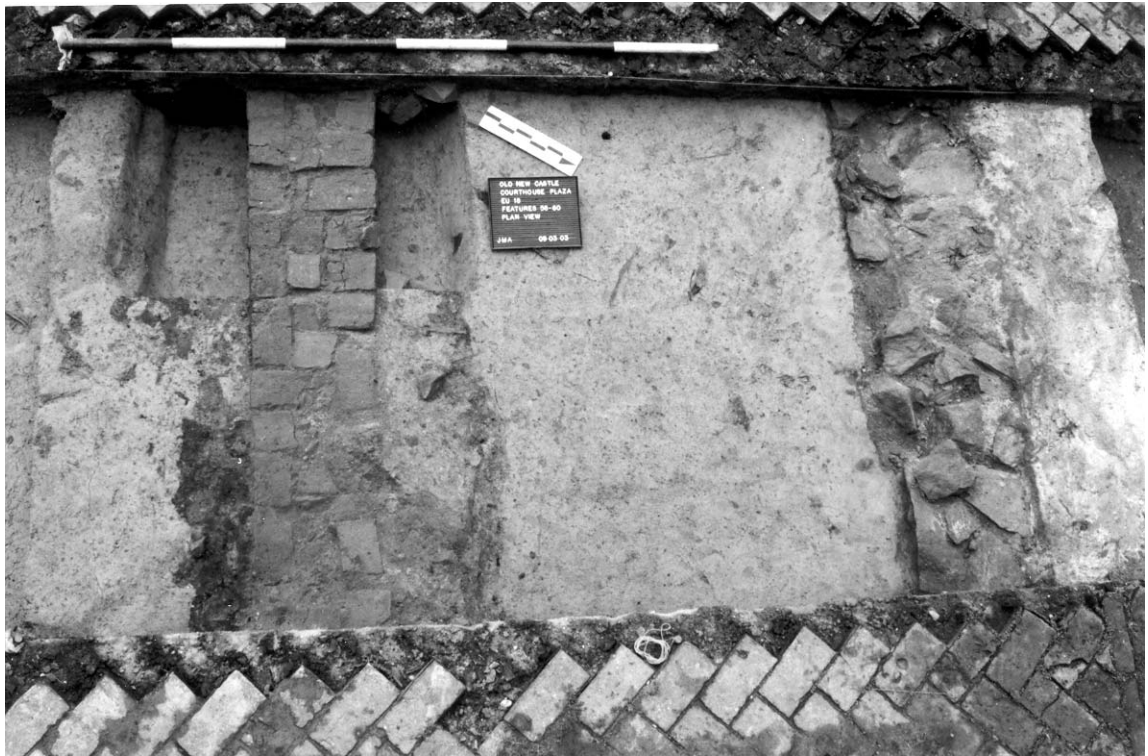
Plate 4. Plan view of EUs 18 and 19 showing the sampled builder's trenches (Features 59 and 60) associated with a brick foundation (Feature 58). The edge of the circa 1820 plaza (Feature 21) is visible on the right side of the photograph; view to grid south.

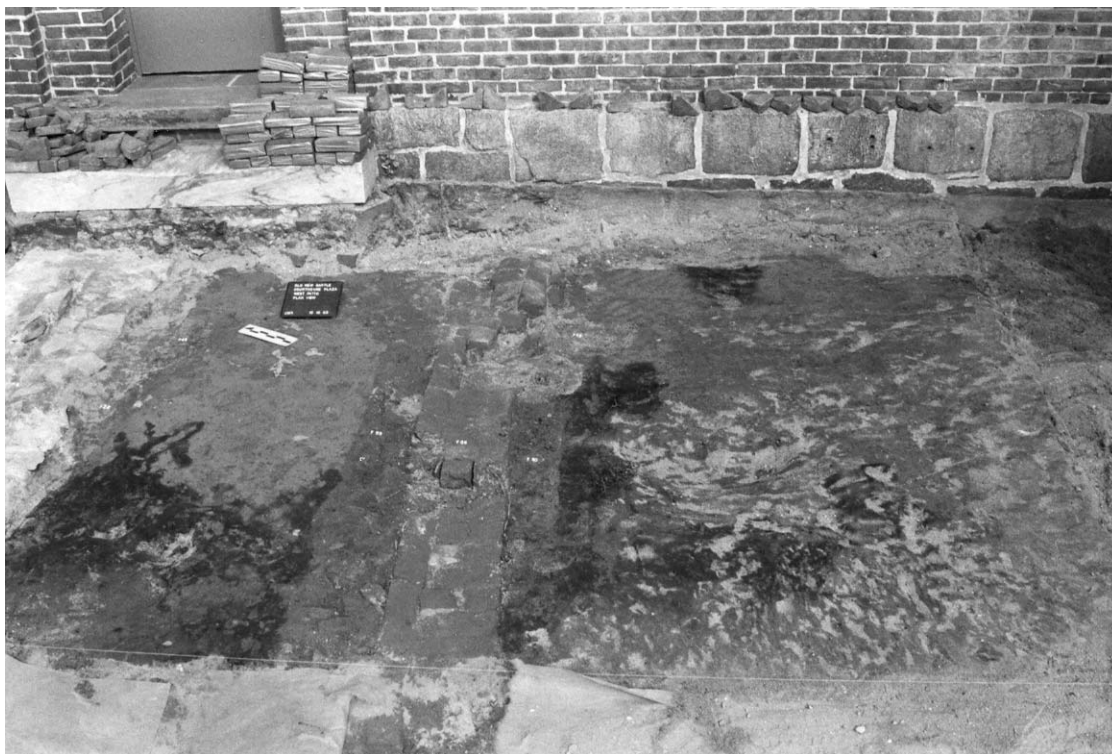
Plate 6. Plan view showing a large burnt area (Feature 93) in the north central section of the west plaza; view to grid north.

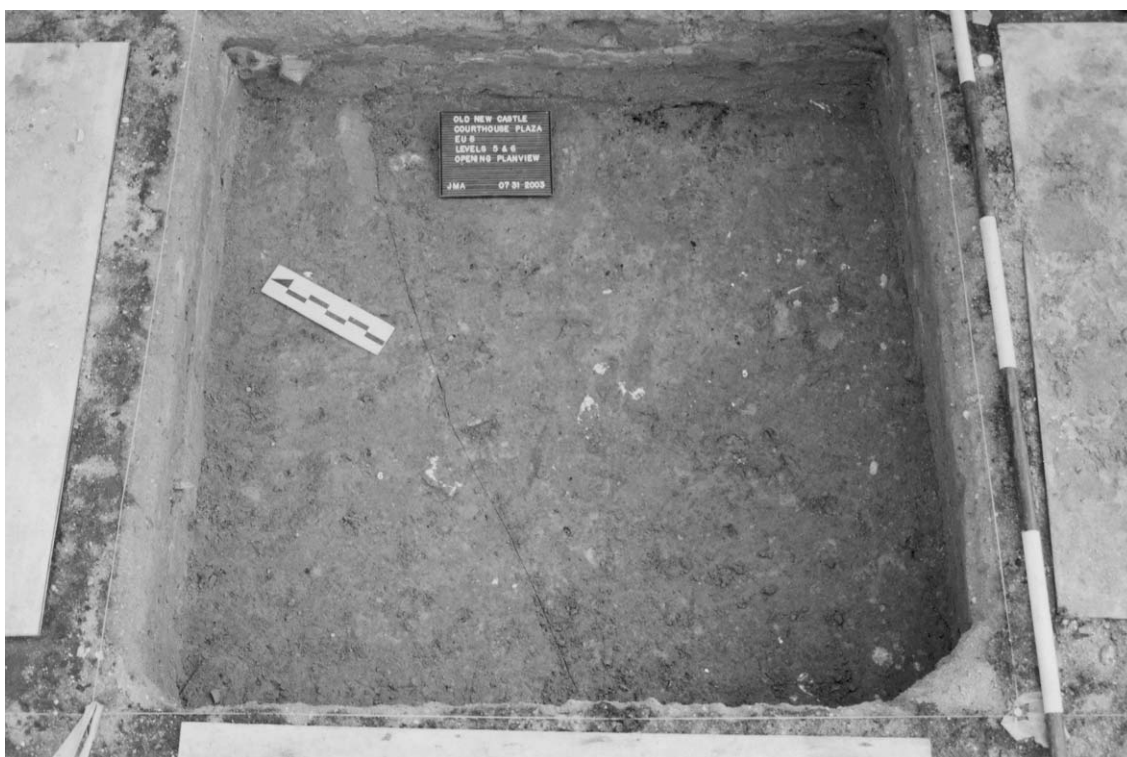
Plate 7. Initial identification of Feature 20 (cellar hole) within the right side of EU 8; view to grid north.

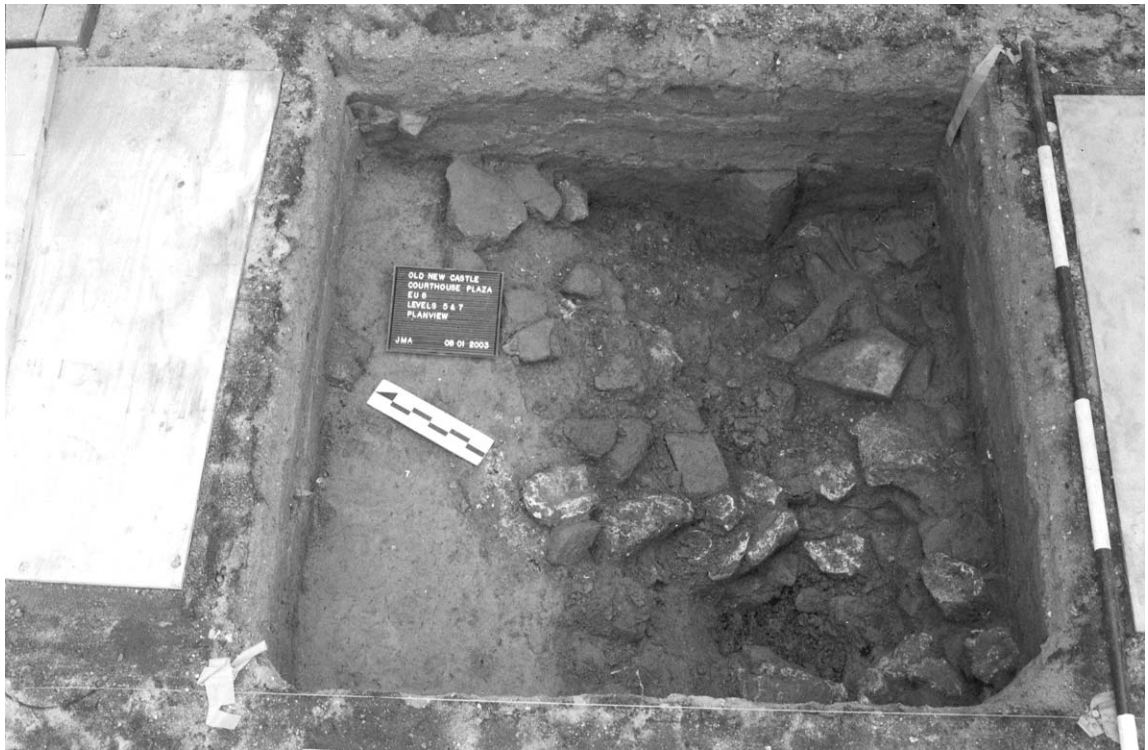
Plate 8. Opening plan view of Level 7 within the Feature 20 (cellar hole) showing high concentrations of coral, stone, and brick; view to grid north.

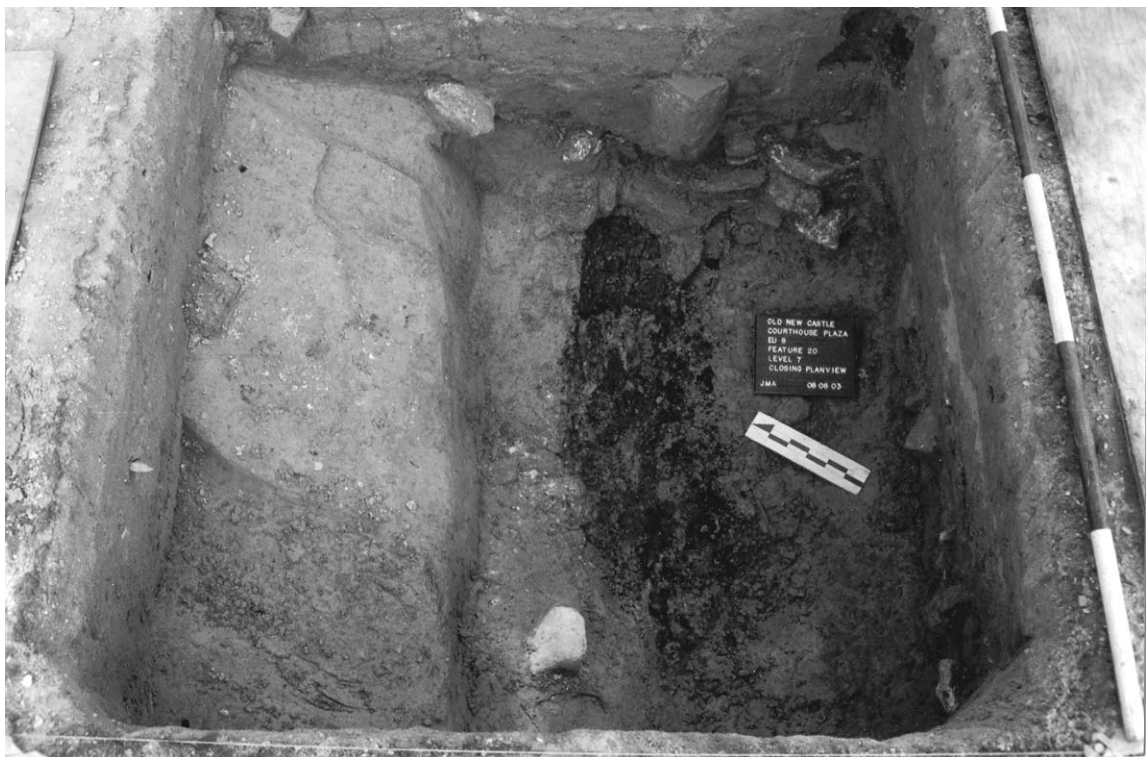
Plate 9. Closing plan view showing a burnt board at the base of Level 7 in the cellar hole (Feature 20); view to grid north.

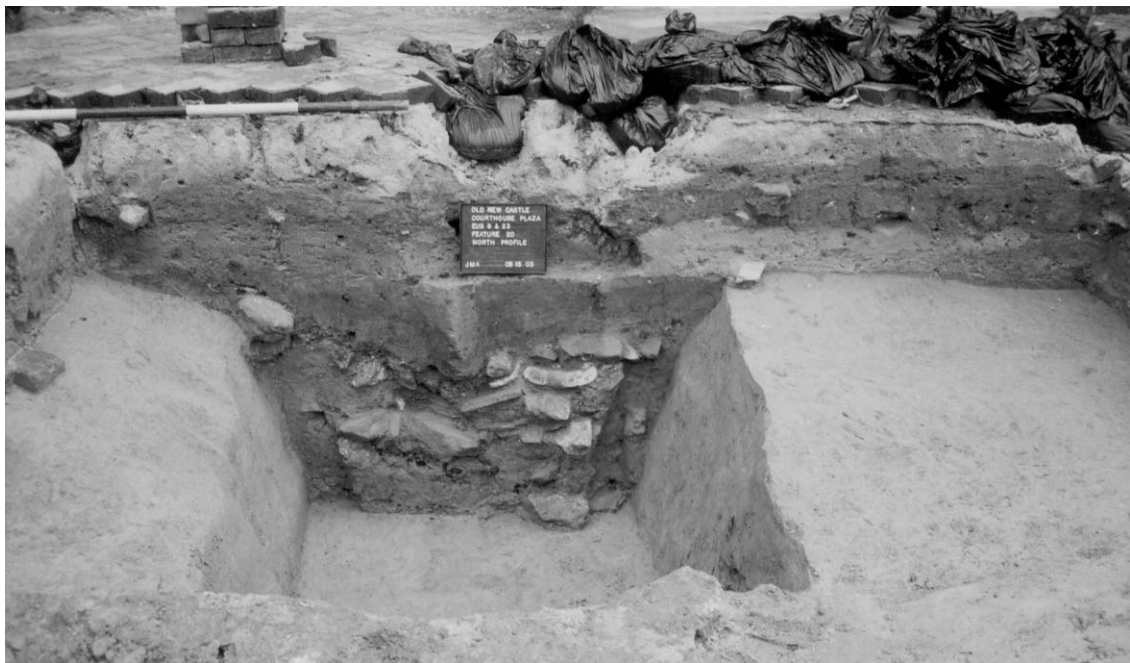
Plate 10. North profile of EUs 8 and 23 showing a fully sectioned (cellar hole).

In total 1,475 artifacts (approximately 21 percent of the total assemblage) were recovered from the sampled portion of Feature 20 within EUs 8 and 23. Nearly 80 percent of the assemblage was comprised of floral/faunal material ($n=1175$) including 785 pieces of bone, one horn, 74 brain coral fragments (167.5 lbs.), 313 pieces of shell (311 oyster, 1 clam, 1 whelk), five charcoal fragments, and a burnt walnut shell. Approximately half of the oyster shell fragments ($n=168$) derived from contexts 49 and 51 were found cemented with mortar and likely indicate mortar production rather than simply food consumption. Domestic artifacts ($n=78$) included five tin glazed earthenware (1 plain, 4 with blue decoration), one yellow Staffordshire, eight red body coarse earthenware (possibly indicative of Borderware), 11 redware, two gray Westerwald sherds with cobalt blue decoration, eight pieces of creamware, one pearlware, three pieces of Chinese export porcelain, 31 bottle glass fragments (11 free blown olive green, 16 unidentified olive green, 4 unidentified clear, and 2 unidentified aqua), and five tableware glass fragments. Items of a personal nature ($n=83$) were also well represented within the sampled portion. Included within this category were two buttons (a bone center hole and 1-piece cast brass loop shank), eight brass straight pins, one brass buckle or fastener, 13 European flakes, a possible flint strike-a-light, and 58 ball clay pipe stem and bowl fragments. A number of architectural items including brick fragments, both red (approximately 117 lbs. total weight) and yellow ($n=6$, total weight of 2.3 lbs.); 13 mortar pieces (3 lime and 10 sand); 28 nail fragments (14 unidentified and 24 cut or wrought); one unidentified metal hardware; a burnt wooden plank; numerous stone fragments; 39

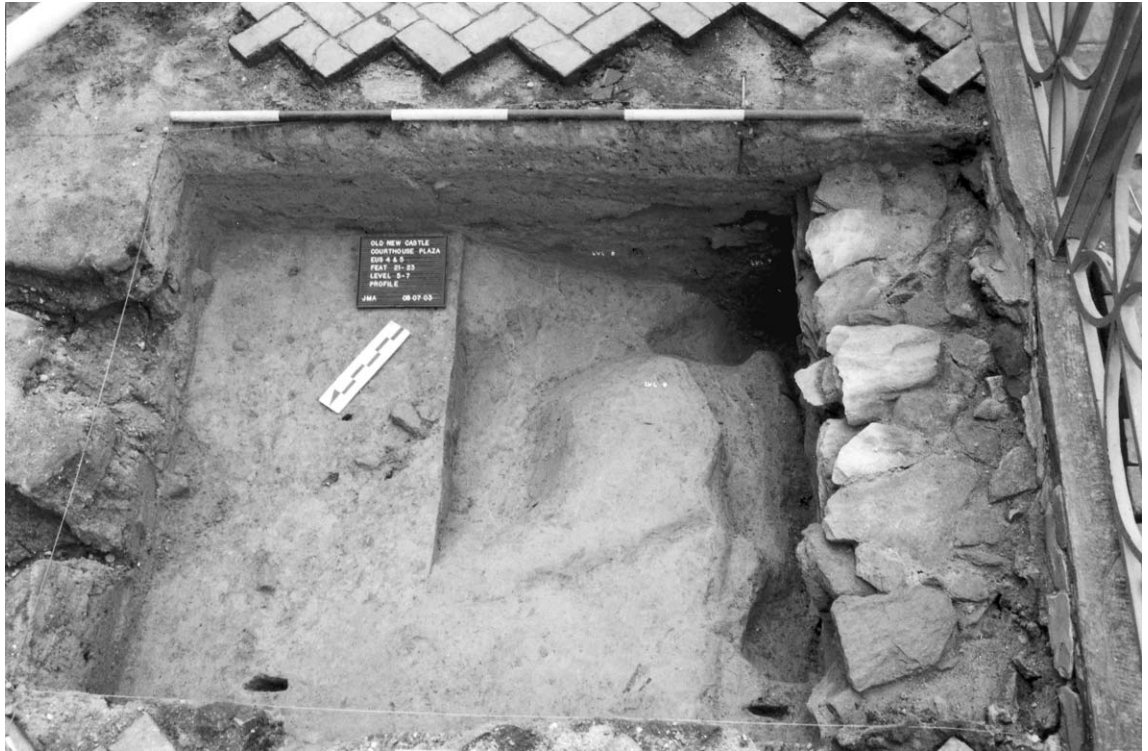
Plate 11. East profile of EUs 4 and 5 showing south bisection of Feature 23 (erosion trench) and the completed excavation of the ca. 1820 patio wall builder's trench (Feature 22).

Feature 23, identified at the base of the lower sand deposit cuts into the surrounding subsoil within EUs 4 and 5 (Plate 11). The base of this concave shaped feature measures 5.5 by 2.2 ft. with an overall depth range of 0.2 to 0.6 ft. It slopes away from the southeast corner of the circa 1732 central block, for a general orientation that is northwest to southeast. A total of 103 artifacts were recovered from this completely excavated feature and a TPQ of 1740 was assigned based on the recovery of three sherds of Jackfield-type redware (context 19). The mean artifact date was 1716.7 and the feature has an occupation date range of 1689.9 to 1743.6. The rest of the assemblage included faunal remains such as bone, coral, clam and oyster shell fragments; personal items such as a brass straight pin, ball clay pipe bowl and stem fragments; seventeenth and eighteenth-century ceramics including buff-bodied earthenware including Staffordshire and a possible Midlands yellow, North Devon earthenware with gravel temper, tin glazed earthenware, redware including possibly Red Borderware, early Buckley and Jackfield-type, imported Westerwald stoneware, and Chinese export porcelain; unidentified bottle fragments; and architectural items such as cut/wrought nails, brick, and window glass.

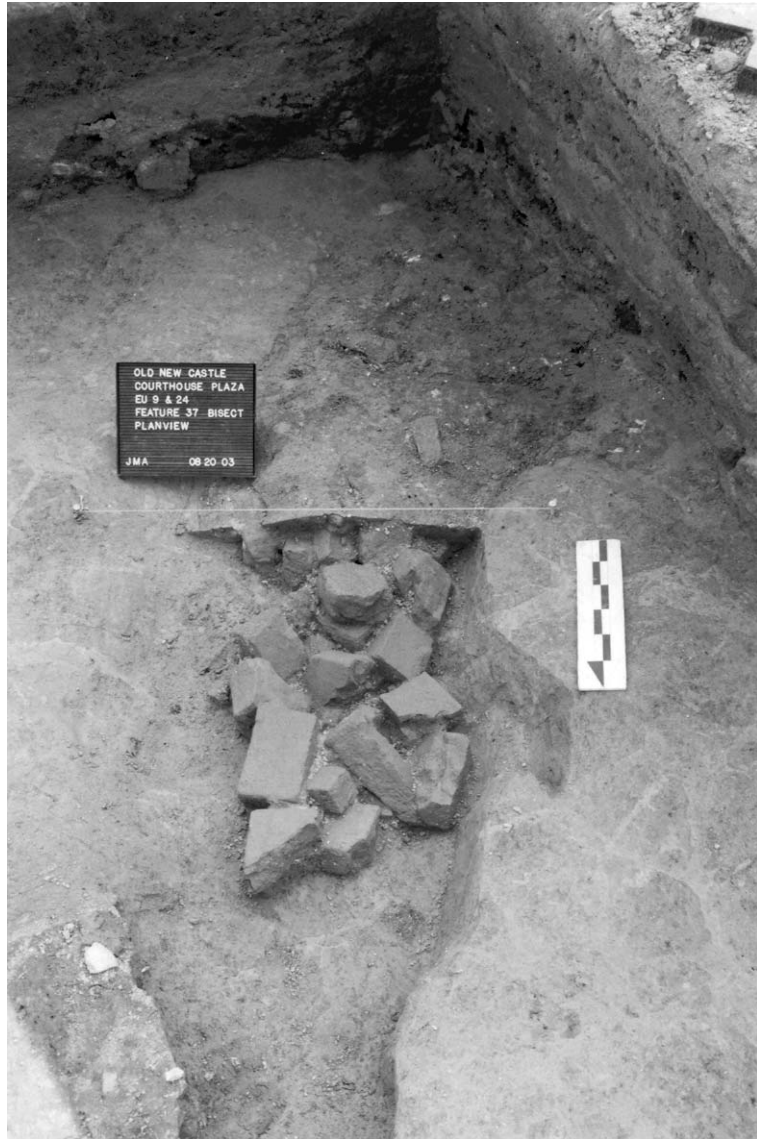
Plate 12. Plan view of Feature 37 (erosion trench) bisection within EUs 9 and 24; view to grid east.

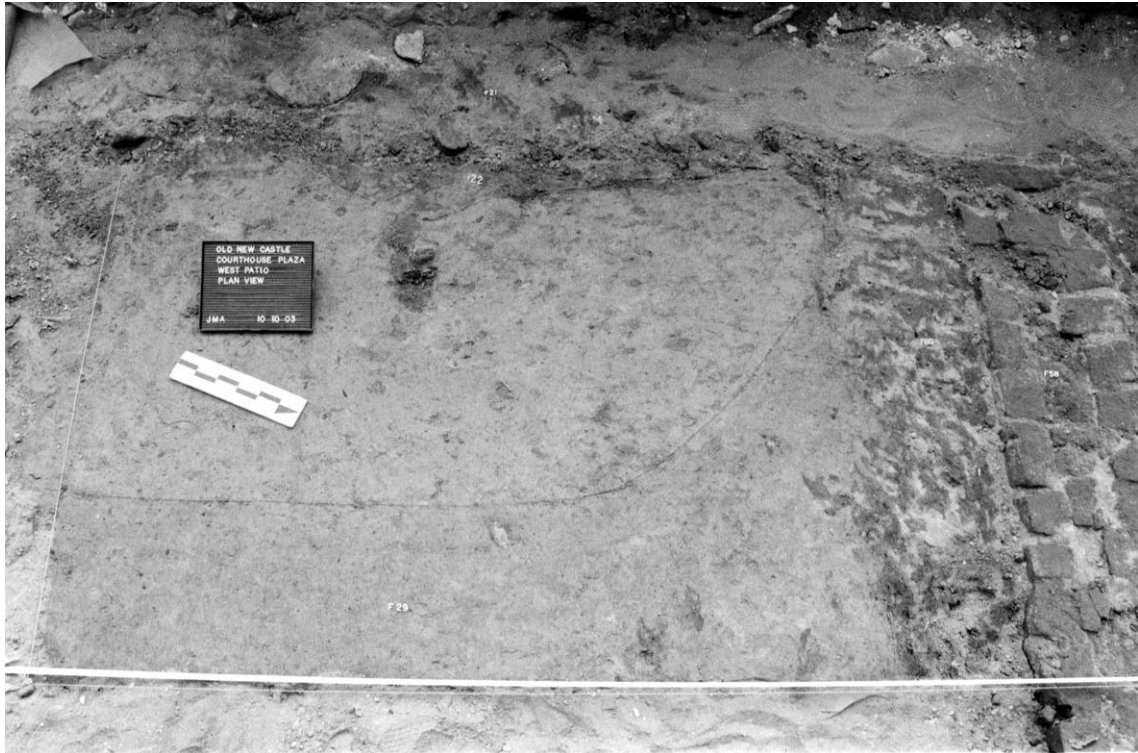
Plate 14. Plan view documenting the southern palisade (Feature 29) orientation shift within the western plaza; view to grid south.

Features 24 and 29 represent the southern palisade trench, which has an east-west orientation and extends nearly the full length of the circa 1820 plaza. The western edge of the trench begins at the eastern side of the brick wall, Feature 58, on the western plaza and it appears to terminate within EU 28 on the east plaza for a total feature length of approximately 73.5 ft. (Figures 5 and 6; Plate 13). It is unclear, however, if this point constitutes the eastern edge, or simply where it was

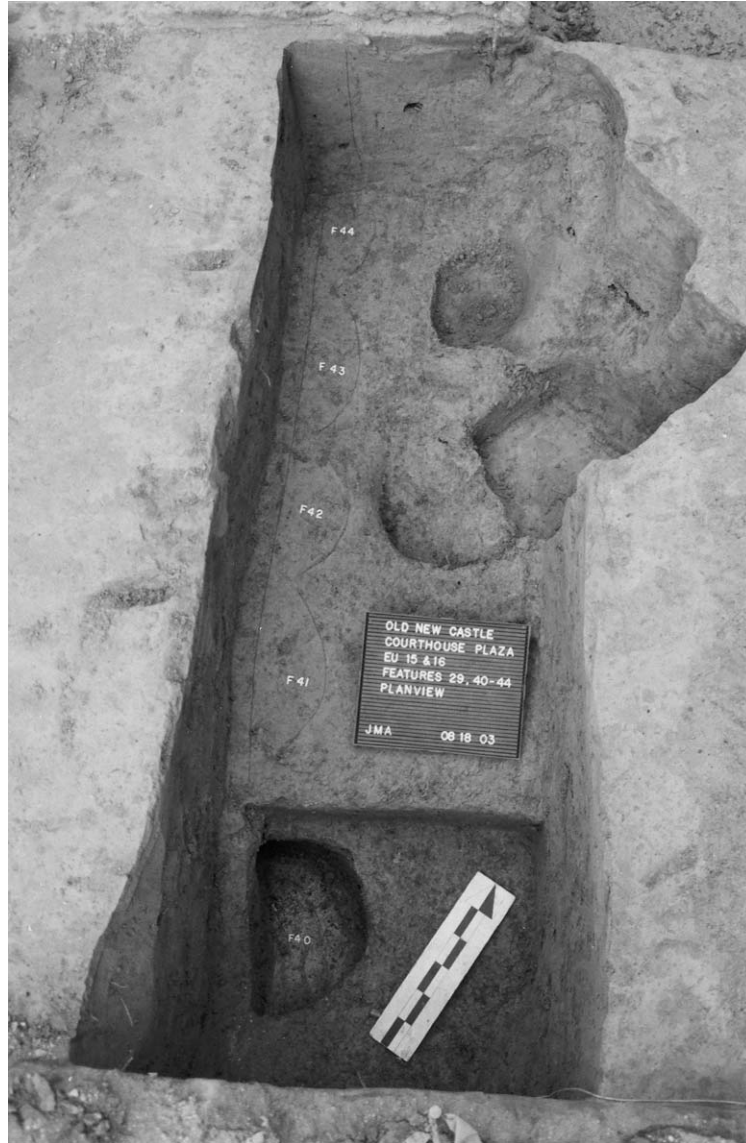
Plate 15. Plan view of excavated palisade trench post holes (Features 40 through 42) within Feature 29, EUs 15 and 16; view to grid west.

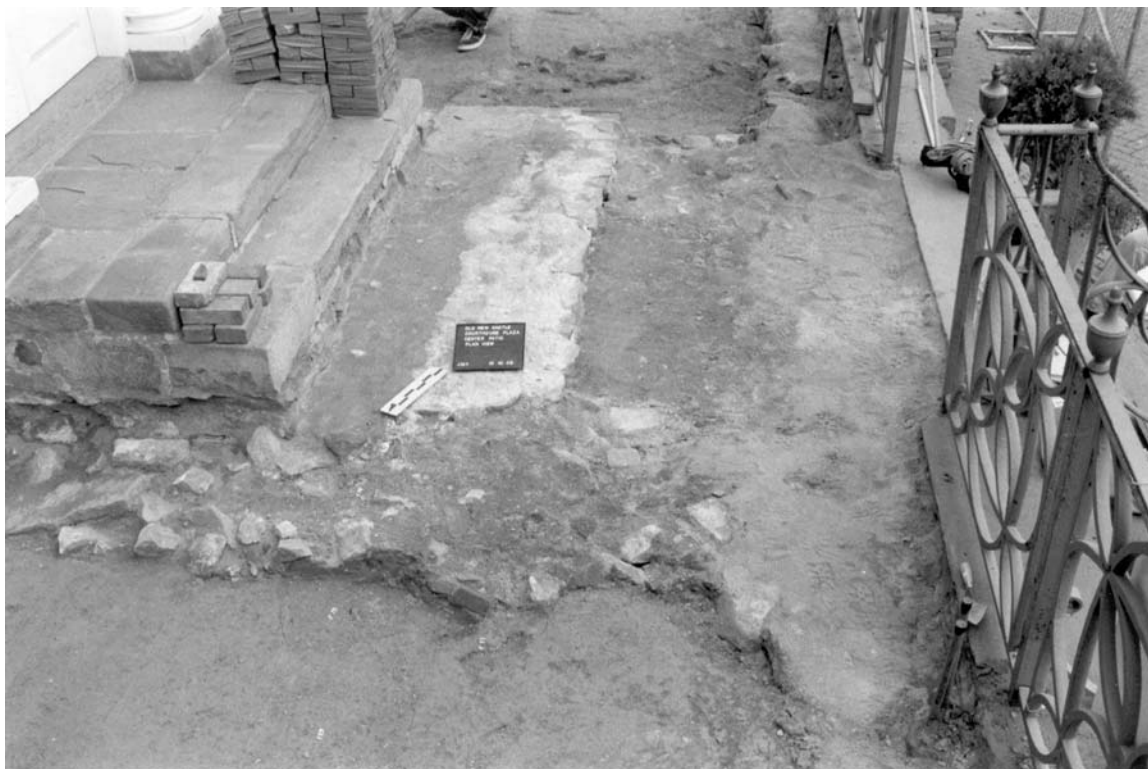
Plate 16. Plan view showing the portico foundation (Feature 78) in the central plaza; view to grid east-northeast.

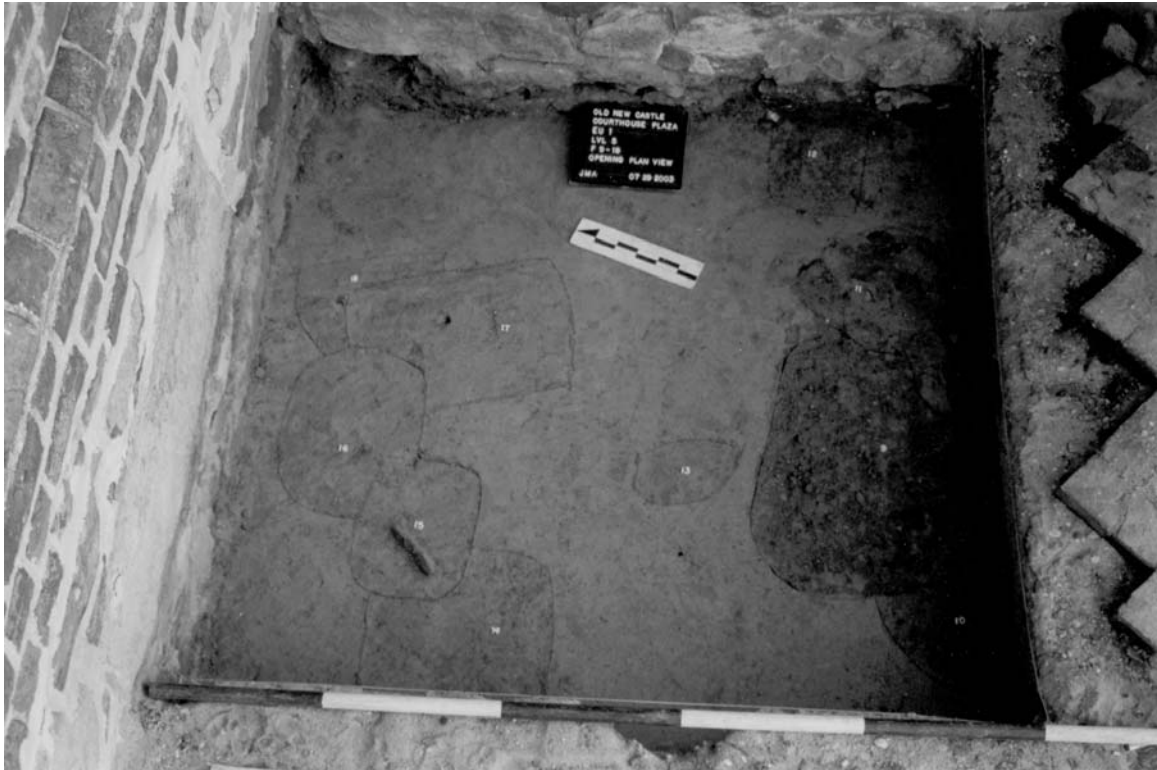
Plate 17. Opening plan view of Level 5 showing Features 9 through 16 (post holes) within EU 1; view to grid north.

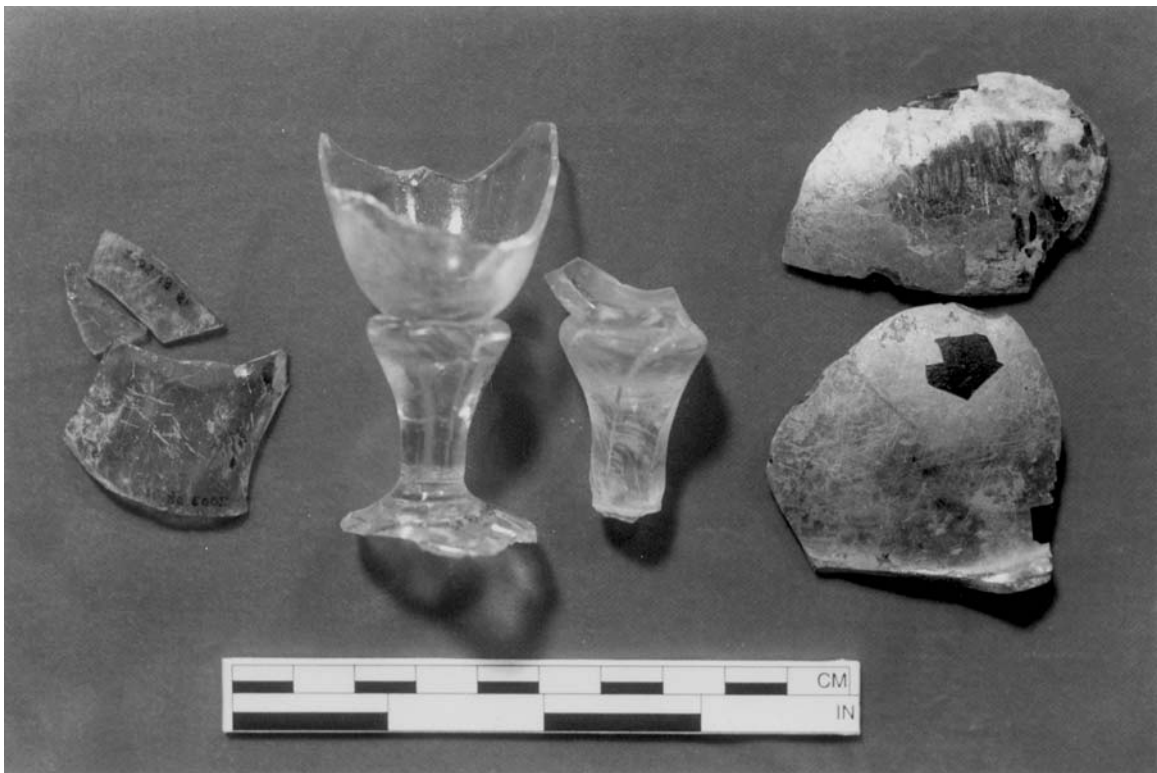
Plate 18. Table and bottle glass recovered from Feature 20 including three mold blown tumbler fragments with lozenge shaped design (left), two Type VI glass stems (center), and two sherds from a free blown bottle (right).

Several fragments ($n=5$) of table glass were recovered from Feature 20 (Plate 18). Two of the fragments are comprised of clear glass stems, while the remaining assemblage represents a drinking vessel or tumbler. The aqua colored glass tumbler exhibits a mold blown lozenge or bull’s eye shaped design (context 51). Following the typology presented by Noel Hume (1969:191) the remaining examples (derived from context 43) are quatrefoil stems where the baluster is pinched into four segments (type VI, dated 1685-1705). Although not derived from Feature 20, a third stemware was recovered from nearby EU 7 (SU E, context 37); this vessel, although similar, appears to be a heavy inverted baluster with tear (type VII, dated 1690-1710).

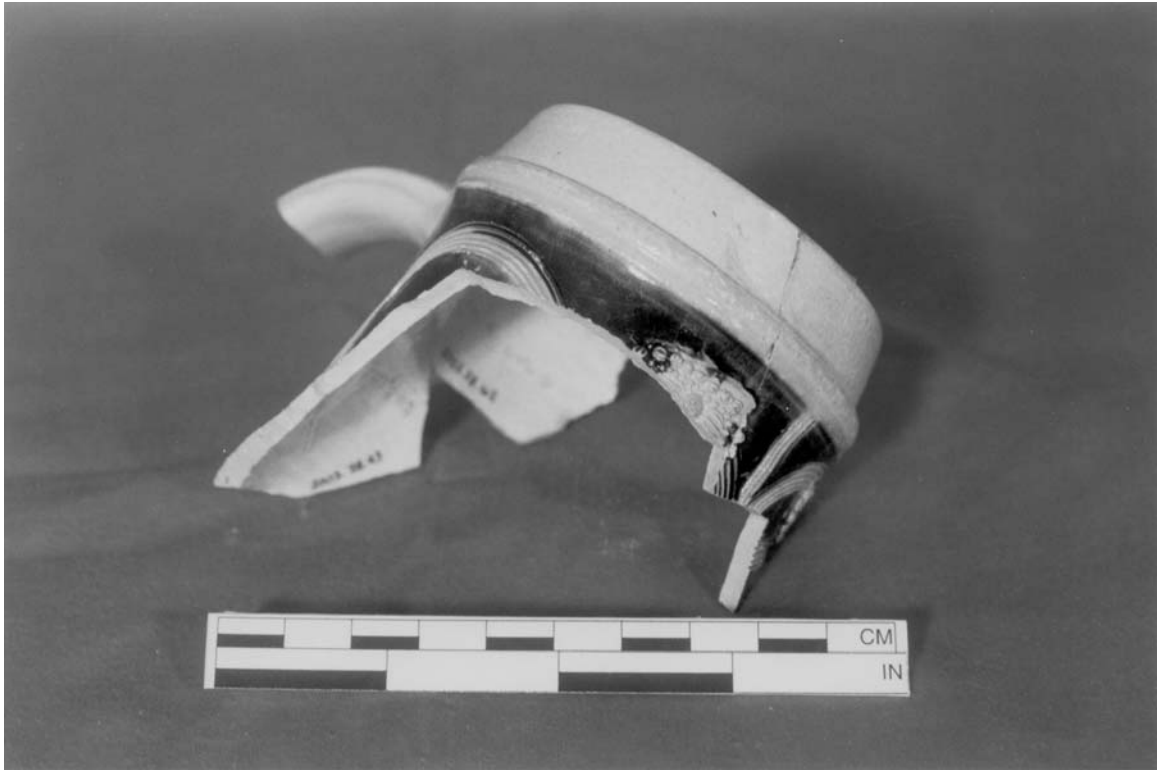
Plate 20. Mended neck and rim fragments from a gray Westerwald stoneware drinking jug derived from Feature 20.

Fragments from the neck and rim of a gray Westerwald stoneware vessel ($n=4$) mended between Feature 20 (contexts 43 and 44) and SU E within units 9 and 23 (contexts 62 and 146). The rim diameter measures 2.5 in. and a partial handle extends from the neck (Plate 20). A slight flaring of the sides of the vessel indicates that its form is that of jug not a mug. The body is decorated with blue cobalt, incised lines, and medallions. No body or basal sherds were recovered for this vessel, so its overall dimensions remain unknown.

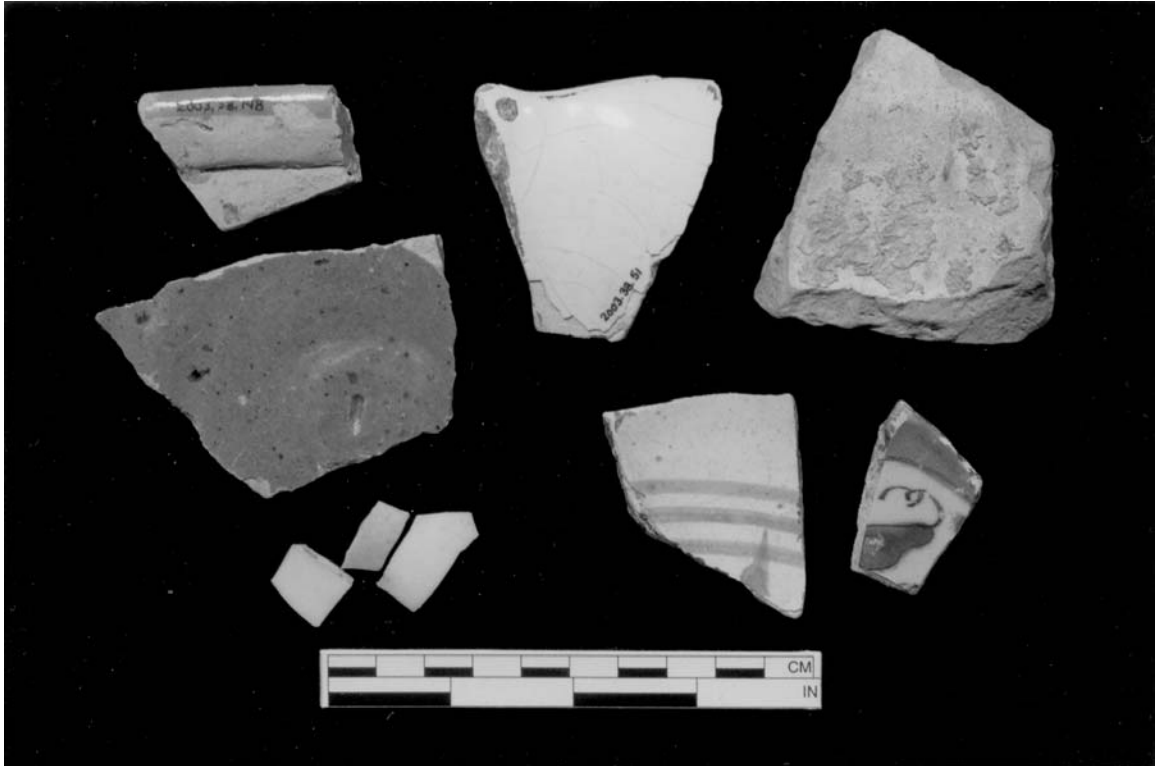
Plate 21. Ceramic analysis identified a number of seventeenth to eighteenth century vessels including, top row: two possible red border ware fragments (left); a tin glazed sweetmeat or high sided bowl (center); and a possible Donyatt milk pan (right). Bottom row: three plain hard paste porcelain sherds (left); tin glazed flatware decorated with three hand painted blue lines (center); and a possible tin glazed charger adorned by a representational motif (right).

The analysis of ceramics and glass from Feature 20 resulted in the identification of nine additional vessels (Plate 21). The intent of this section is to provide a more detailed examination of the ceramics contained within Feature 20, the backfilled cellar hole. Since the approximate date of the infilling is circa 1674-1725, this examination will focus on the ceramics dating from that time period. The small number of creamware, pearlware, and Chinese export fragments are removed from the discussion (see Section 3.5.5).

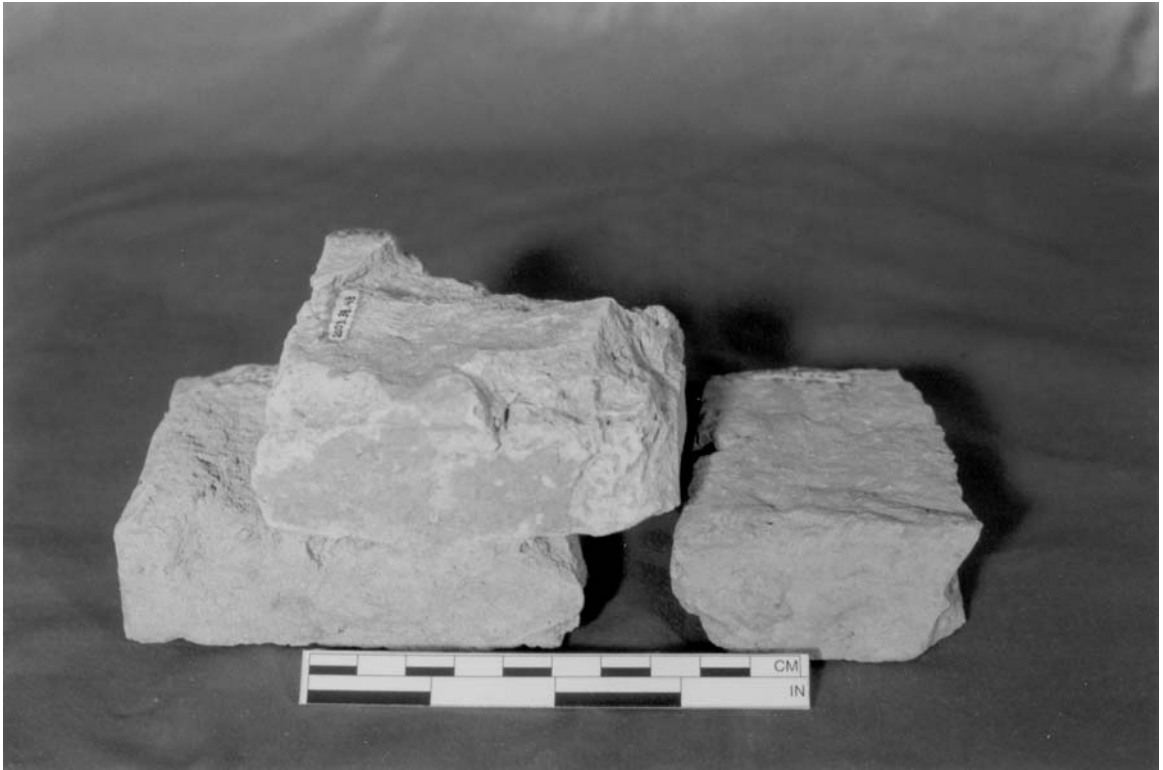
Plate 23. Small brick type of Dutch origin referred to as *drielingen* recovered from Feature 20.

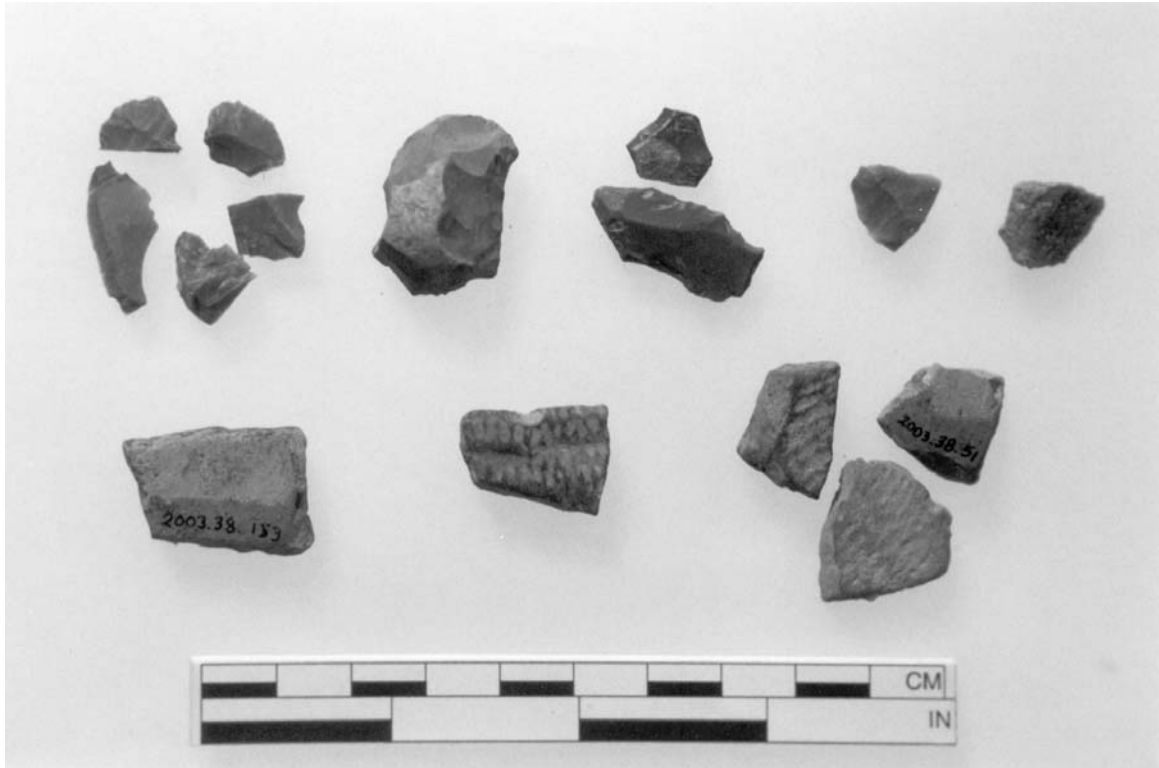
Plate 24. Prehistoric artifacts recovered from Feature 20 including, top row: jasper chipping debris and a unifacial scraper (center); bottom row: untyped ceramic sherds.

The assemblage is generally divided between imported fill matrices (within SUs B, F, and I) and intact contexts native to the Court House property (SUs C, E, and J; Features 20, 22, 37, and 60). The former group consists of 52 artifacts recovered from the sand deposits. This material was likely excavated from a nearby (but now unknown) coastal site at the time of the brick plaza construction. The sand fill deposit assemblage was found to contain mostly lithic chipping debris ($n=47$; 90%) including 25 chert, 19 jasper, 2 quartz, and 1 quartzite flakes/shatter. The five remaining items consisted of two untyped projectile points (a jasper notched point and a chert bifurcate), a possible quartzite chopper/cobble tool, and 2 pieces of quartzite fire-cracked rock.

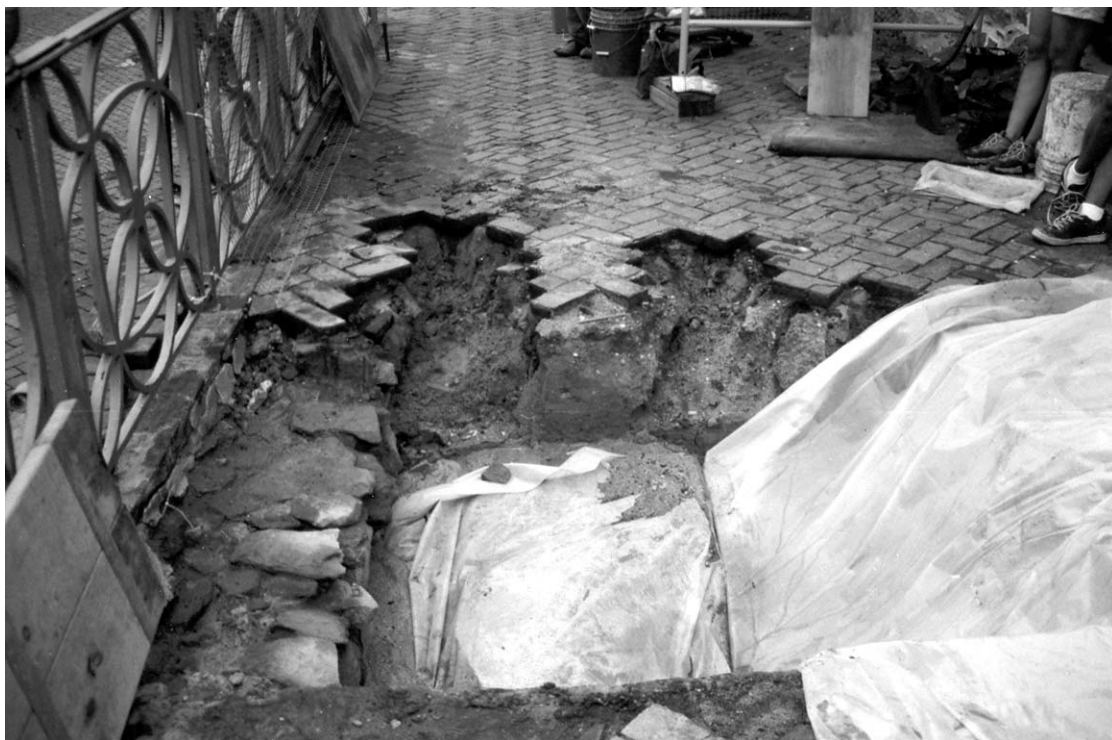
Plate 25. Plaza erosion adjacent to EUs 4 and 5; view to grid west.
