**Historical Documentation
and
National Register of Historic Places Evaluation**

**Lang Impoundment Dike Restoration and Rehabilitation Project
Port Penn, New Castle County, Delaware**

FINAL January 2017

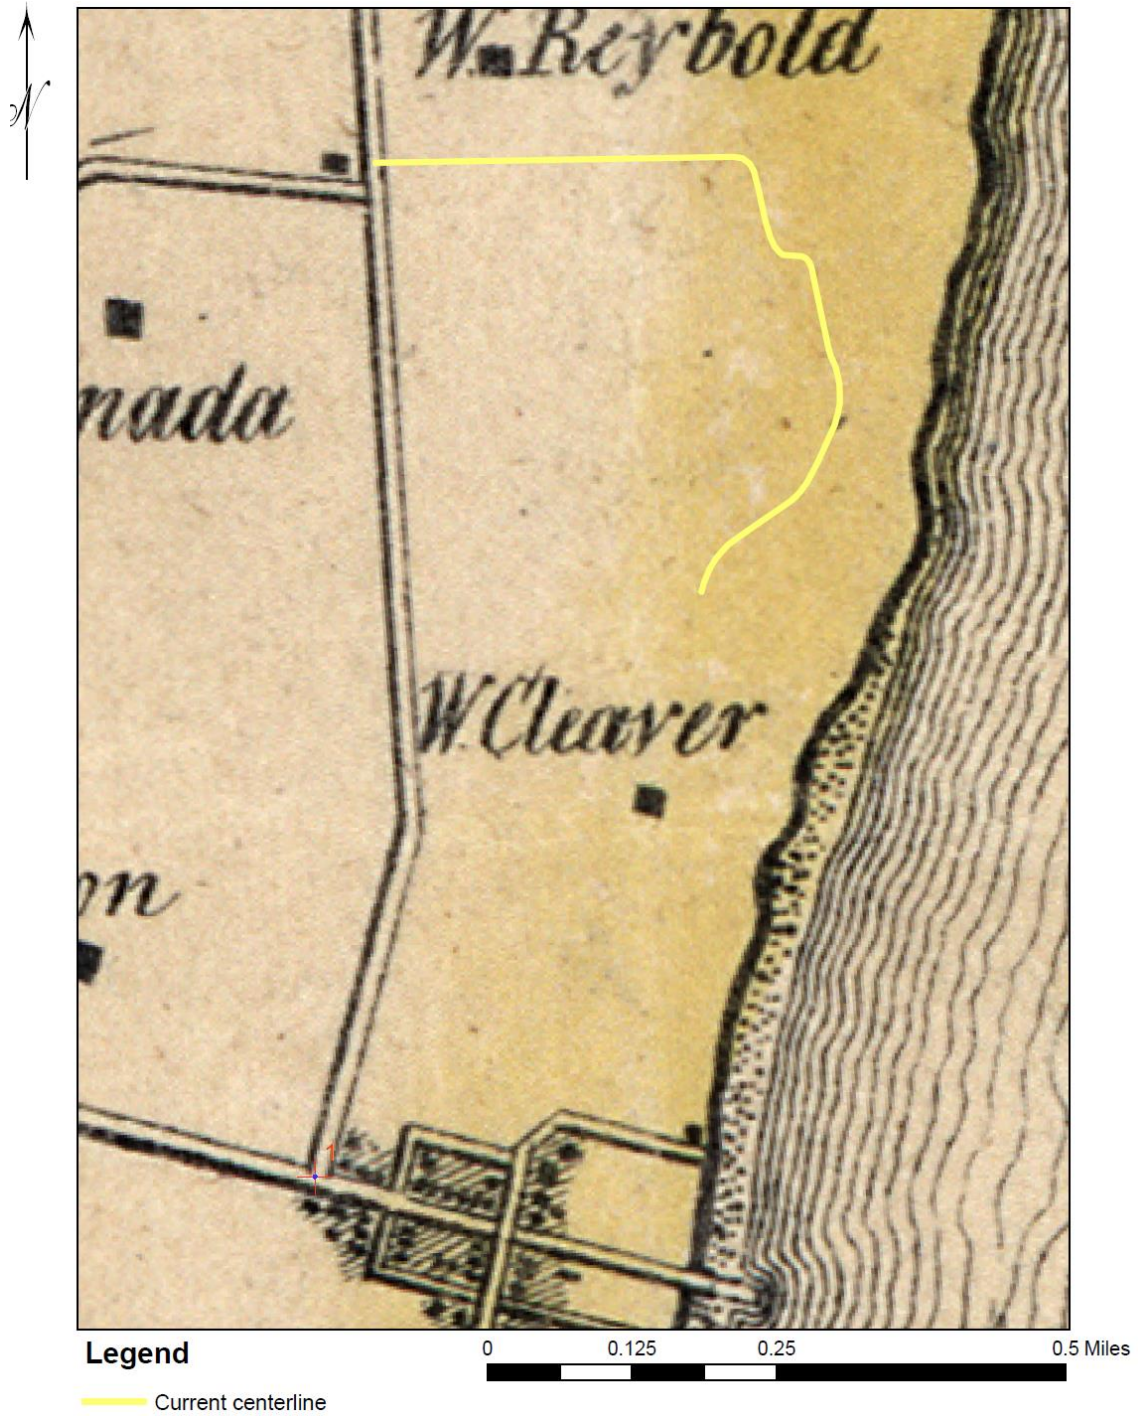
Figure 10. Detail of Hopkins *Map of New Castle County* (1881). Current Lang Impoundment is shown in yellow.

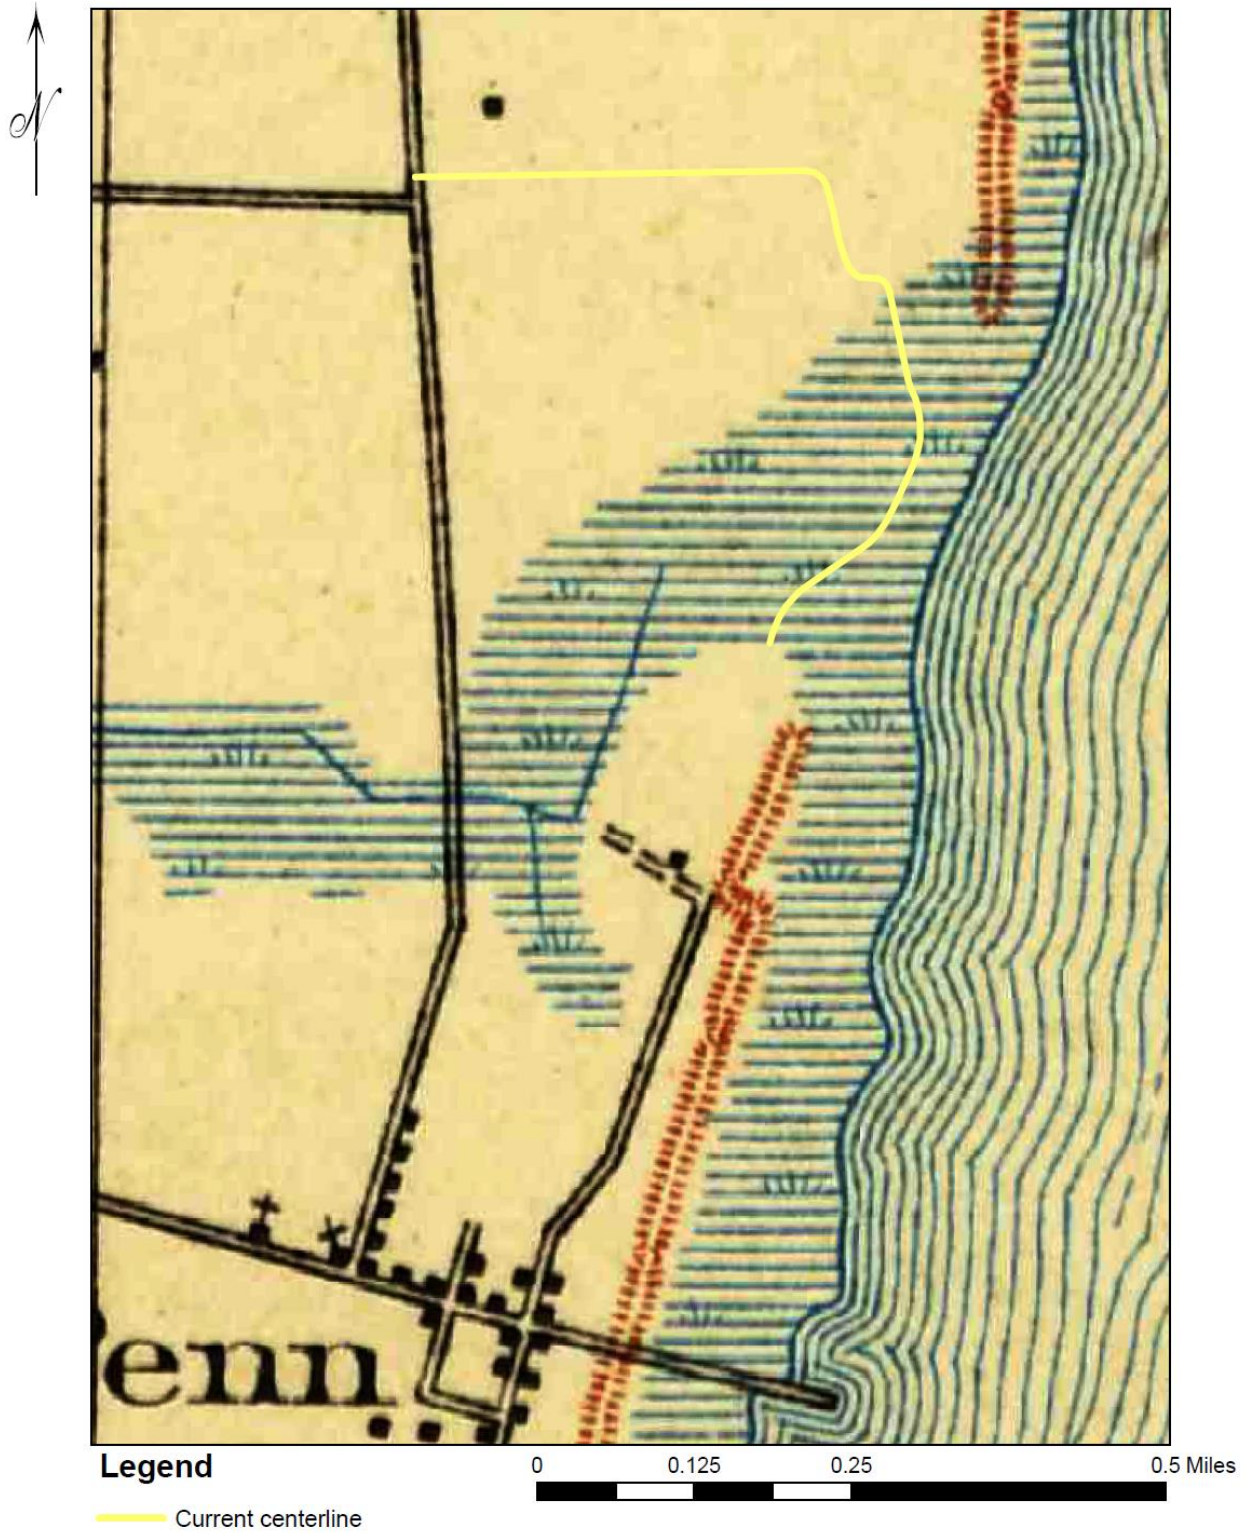
Figure 11. Detail of the USGS Quadrangle Map (1906). Current Lang Impoundment shown in yellow.

A series of US coast and geological survey maps and charts from 1880 to 1906 are the first maps since the 1848 Coast Survey map to show any sort of diking or ditching in the Lang Impoundment project area, but these maps seem to repeat topographical information year after year, with no change or alteration. The 1906 USGS map illustrates the project area with a different configuration of embankments, showing no sign of the chevron-shaped embankment depicted in 1848 (Figure 11). There are embankments shown to the north and south of the impoundment project area and the marsh and drainage of Little St. Georges Creek is also depicted, as is the Congress Street extension to the present Lang Wildlife Management area. It is possible that the earlier dike was destroyed in one of the extreme weather events circa 1880, and no dike was in place by the beginning of the twentieth century that controlled the tide or protected the Port Penn-Delaware City Road.

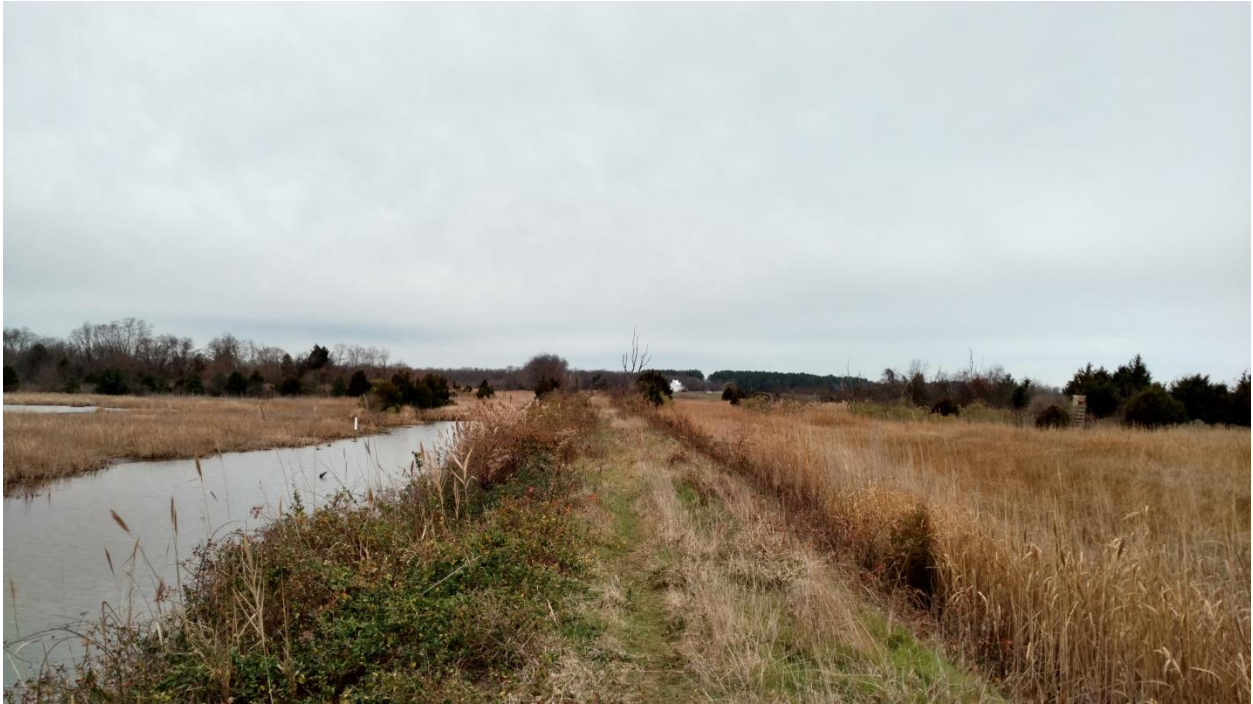
Figure 17. View to the west along the northern embankment wall. Impoundment area to left of image.

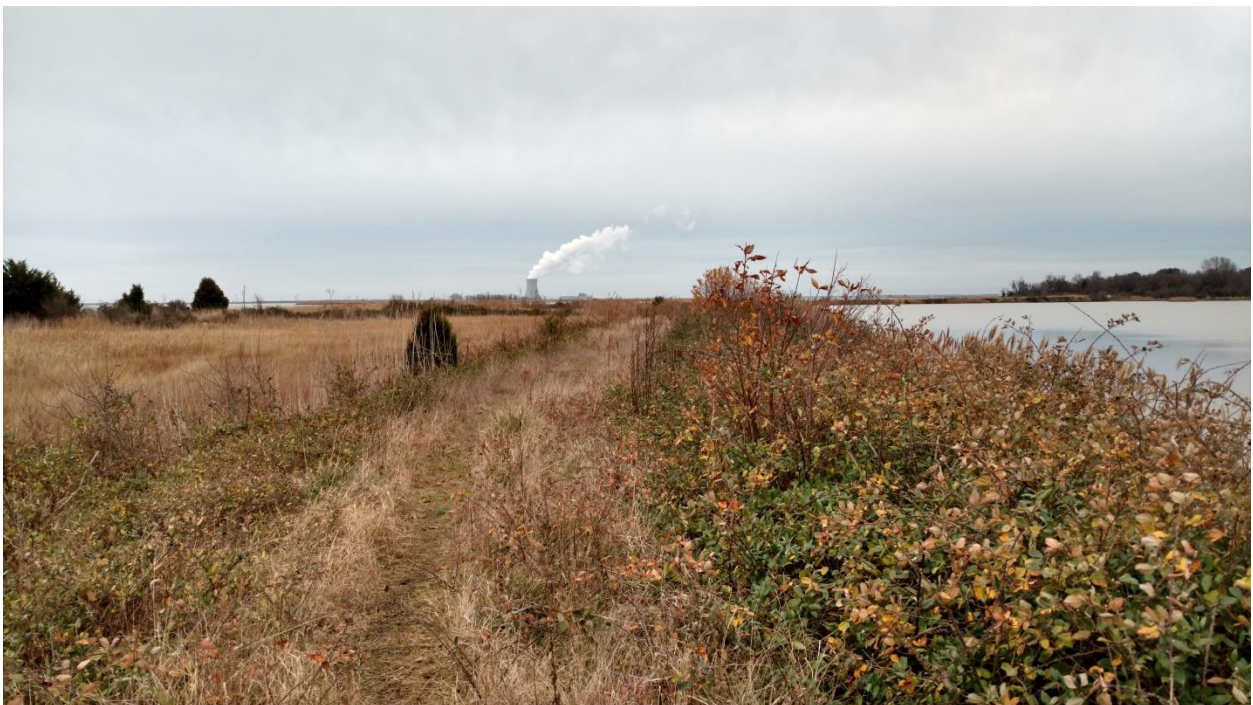
Figure 18. View to the south along the dog-leg portion of the embankment. The Lang Impoundment is to the right, and Salem I nuclear cooling tower is in the distance. Headquarters are in right background.

At the eastern end of the northern embankment, the dike makes a southern dog-leg curve over an area of about 500 feet (Figure 18). This location has a broad drain on the interior (western) side of the dike. Widths of the dike here are comparable to the northern section, and height ranges from about 8 to 9 feet asl. After the dog-leg the eastern embankment (north of the sluice) extends almost due south approximately 600 feet to the concrete and steel sluice. The height of the dike is varies from 8.3 to 7.9 feet als, and the width is ranges from 30 to 50 feet at the base, and from less than 10 feet across at the top, generally averaging about 20 feet across (Figure 19).

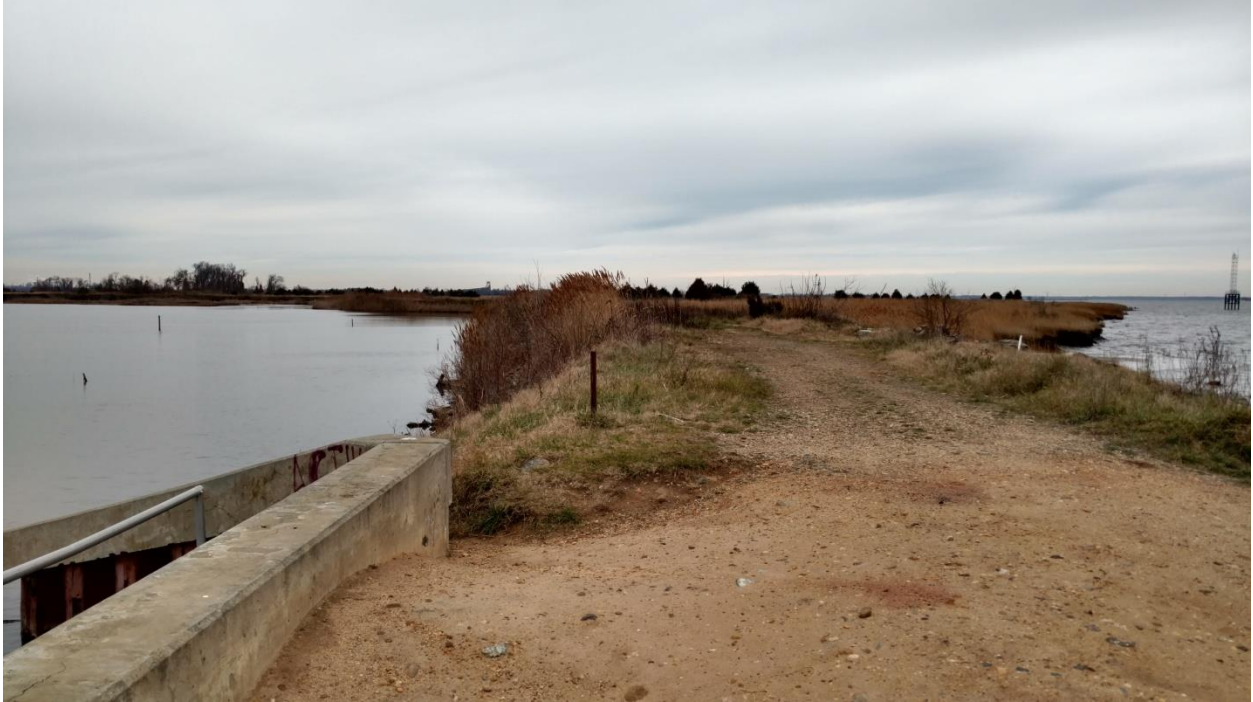
Figure 19. View to the northeast from the sluice, showing the general setting of the embankment north of the sluice.

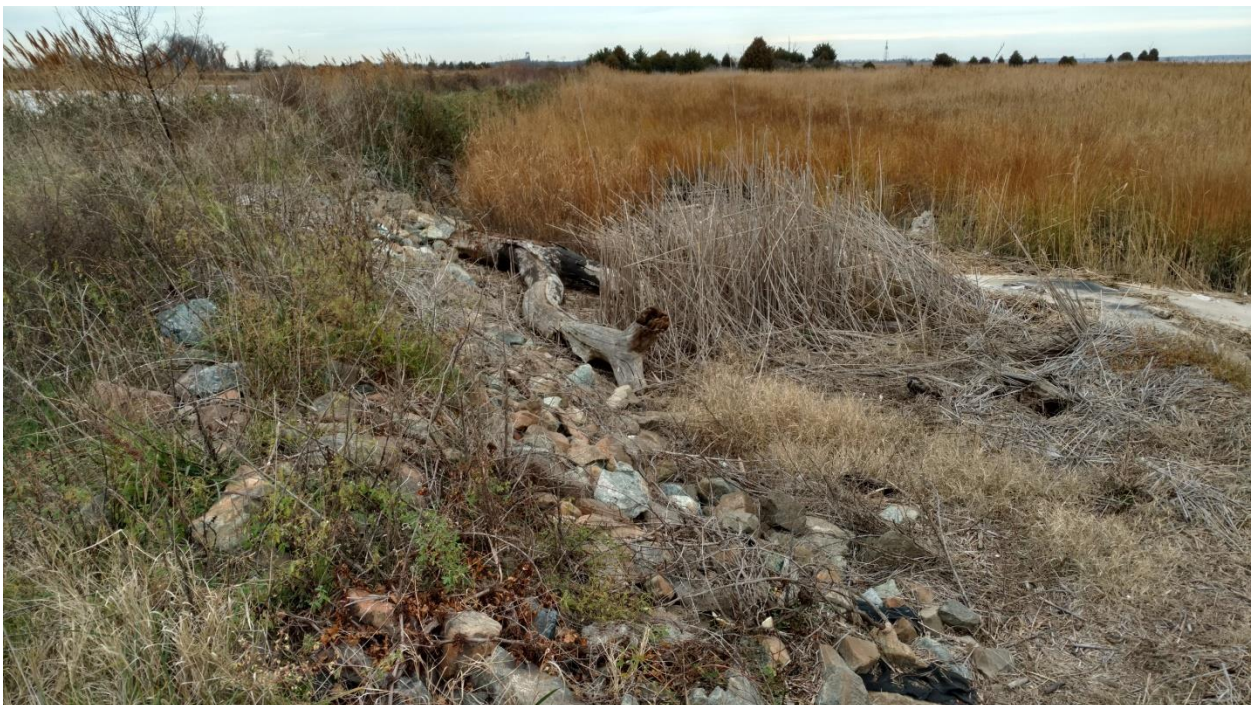
Figure 20. View to north showing Stone mantling (riprap) along river face north of the sluice. Embankment to left of image.

The portions of the embankment fronting on the Delaware River both north and south of the sluice are mantled in stone (Figure 20). Such a method of construction is in keeping with the "prescriptive" technique described in the literature dating to the last quarter of the nineteenth century. In several locations the stratigraphy of the embankment was also visible, consisting of a recent gravel overmantle above a dark earthen core (Figure 21). There is no stone mantling on the northern embankment, and in some places the dirt core is evident. Some evidence of wooden cribbing was observed on the interior of the embankment south of the sluice gate, and in at least one section is located well into the impoundment area (Figure 22 and 23).

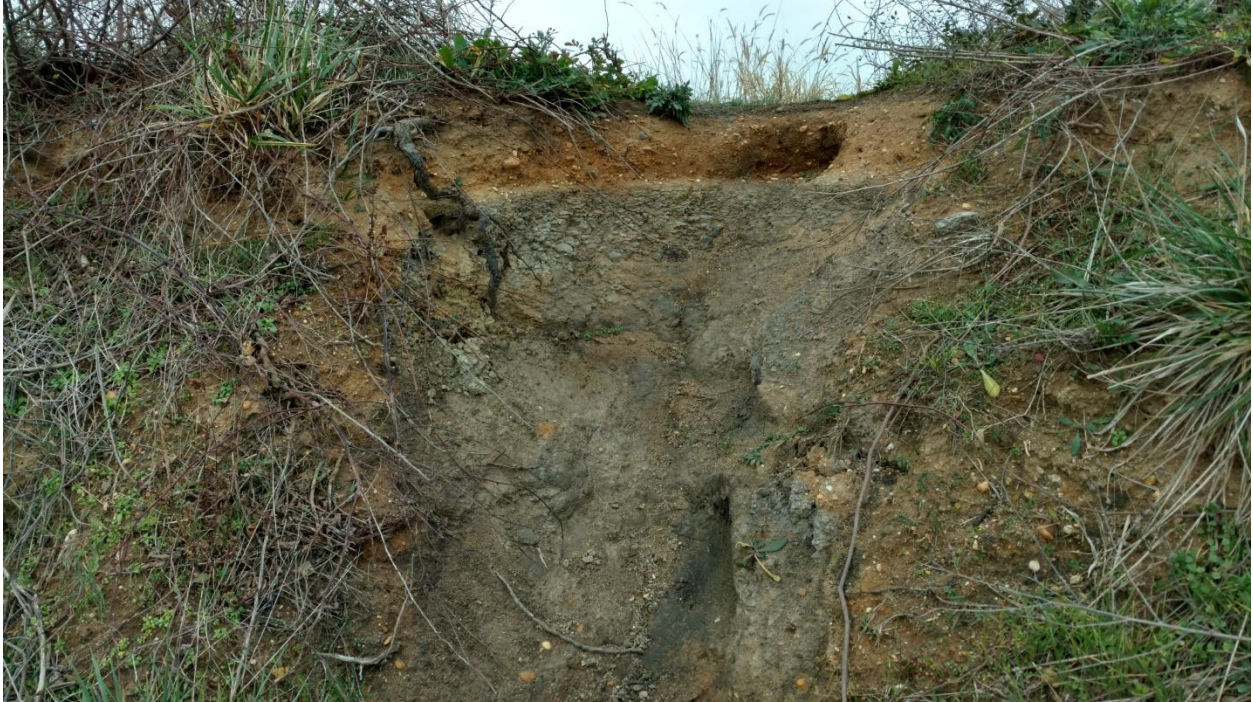
Figure 21. View to east of exposed section of the earthen dike, showing clay core and sandy overmantle. This section is south of the sluice.

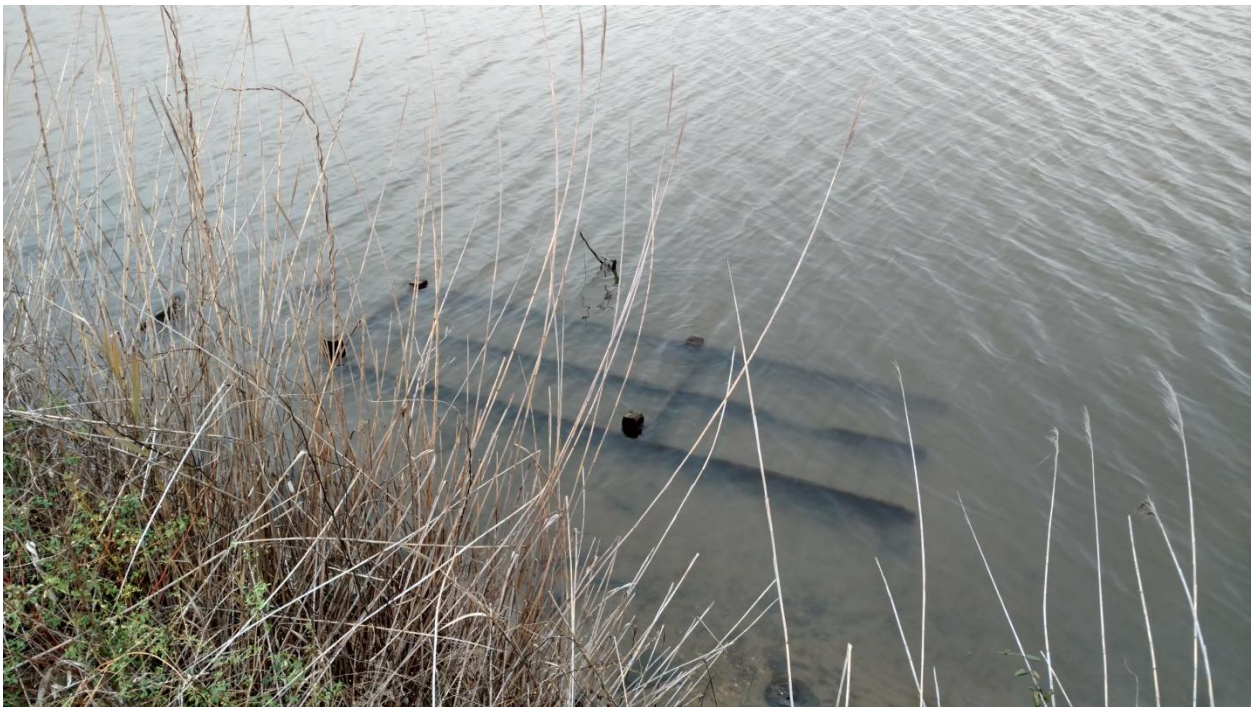
Figure 22. View to the interior of the impoundment showing submerged cribbing. This is located along the southern embankment, south of the sluice.

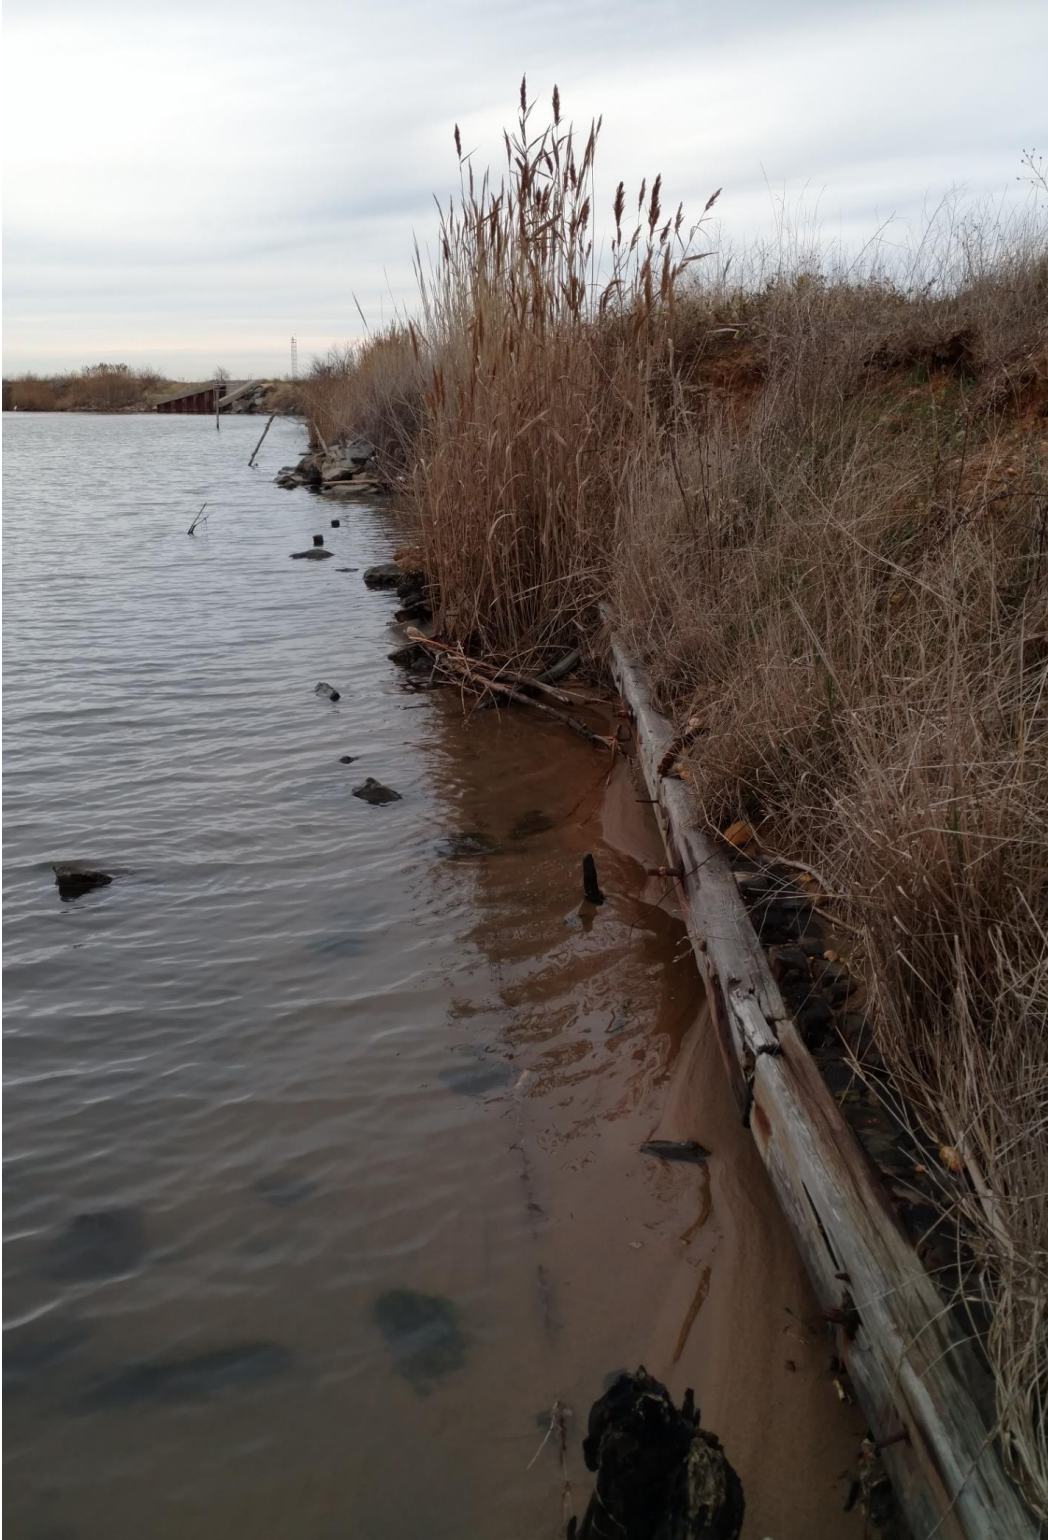
Figure 23. View to the northeast of wooden cribbing on the interior of the southern embankment.

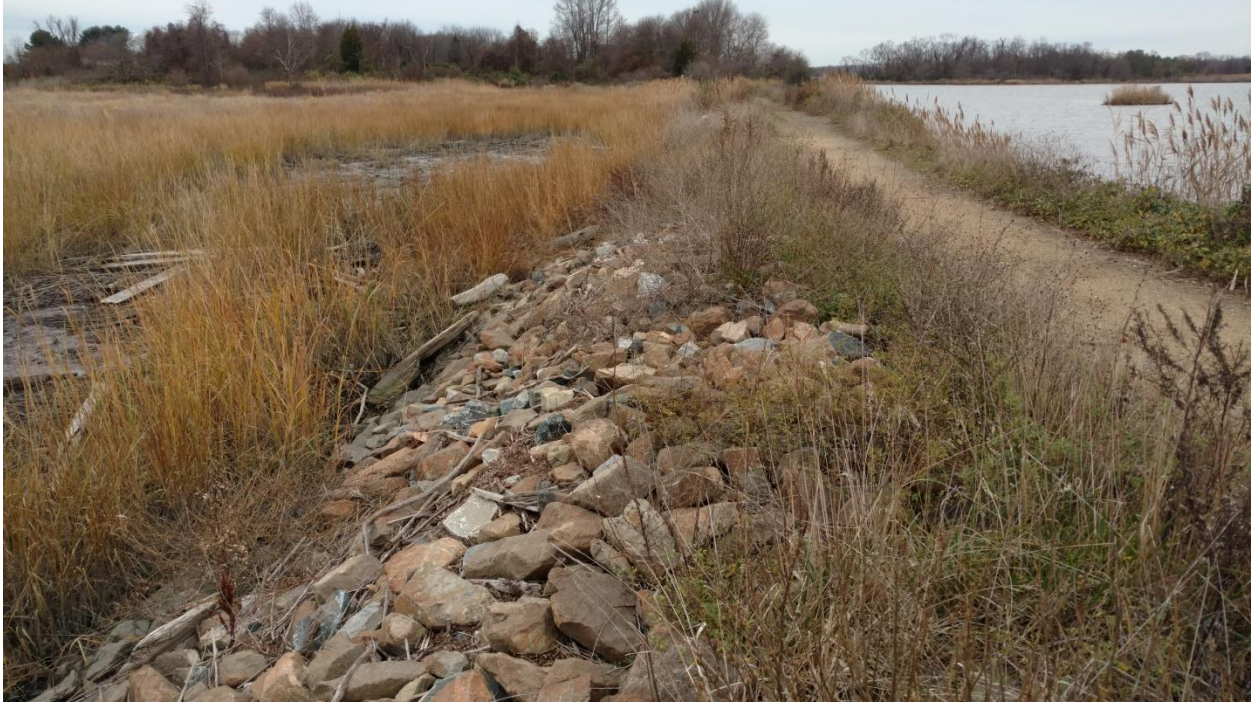
Figure 24. View to the southwest showing the southern embankment and stone riprap along the exterior (river side) of the embankment. Impoundment to the right, and the Lang Headquarters area is in the trees in the center distance.

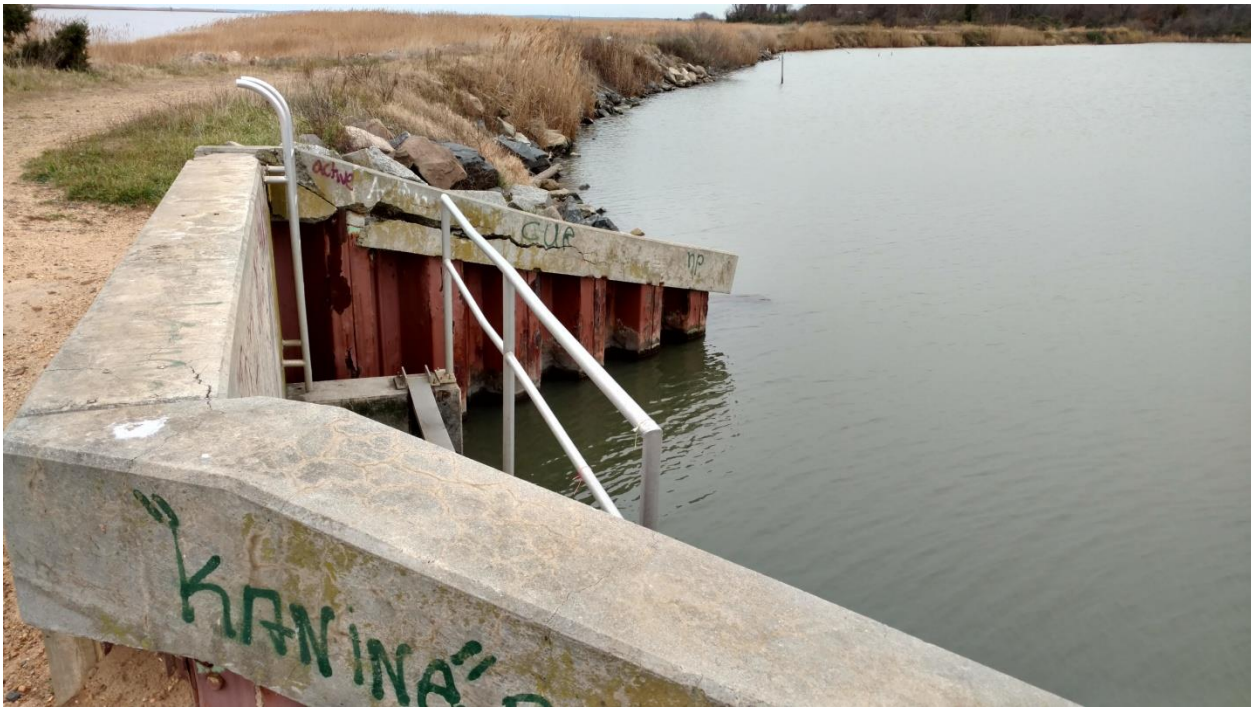
Figure 25. View to the south of the concrete and steel sluice. River is to the left, impoundment to the right.

The sluice gate and wing walls are concrete and steel and appear to be fairly recent in construction (likely put in as a repair in the last two decades) (Figure 25). In the river and visible from the sluice area are timbers. These timbers may represent an earlier dike configuration (possibly the dike depicted on the 1848 survey map) or they are the remnants of three barges, visible on the 1948 USGS map, that were deliberately sunk at the mouth of the sluice, apparently as a protection against tidal action and siltation. That the timbers represent the cribbing structure for an earlier dike is supported by the location of the timbers and the locations of the mapped barges - two of the three barges are significantly south of and further east from the sluice, and are not directly in the location of the visible timbers (Figure 26 and 27).

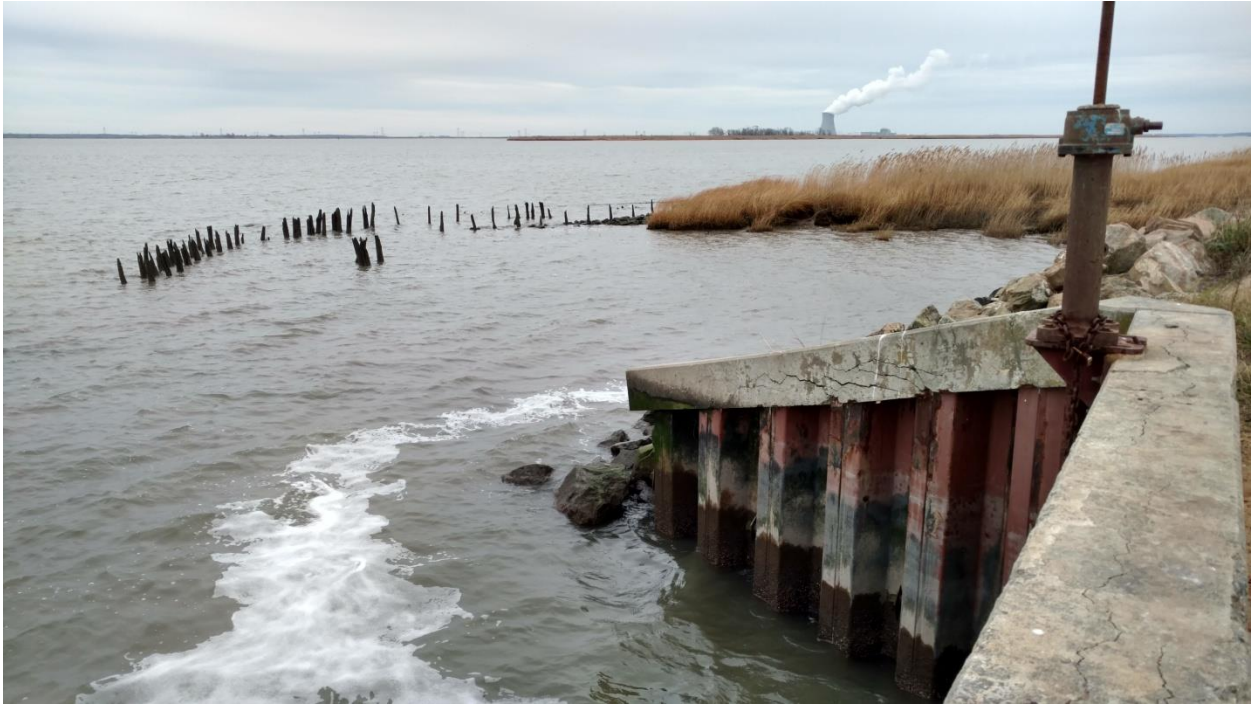
Figure 26. View to the east looking at the timber configuration south of the sluice entrance.

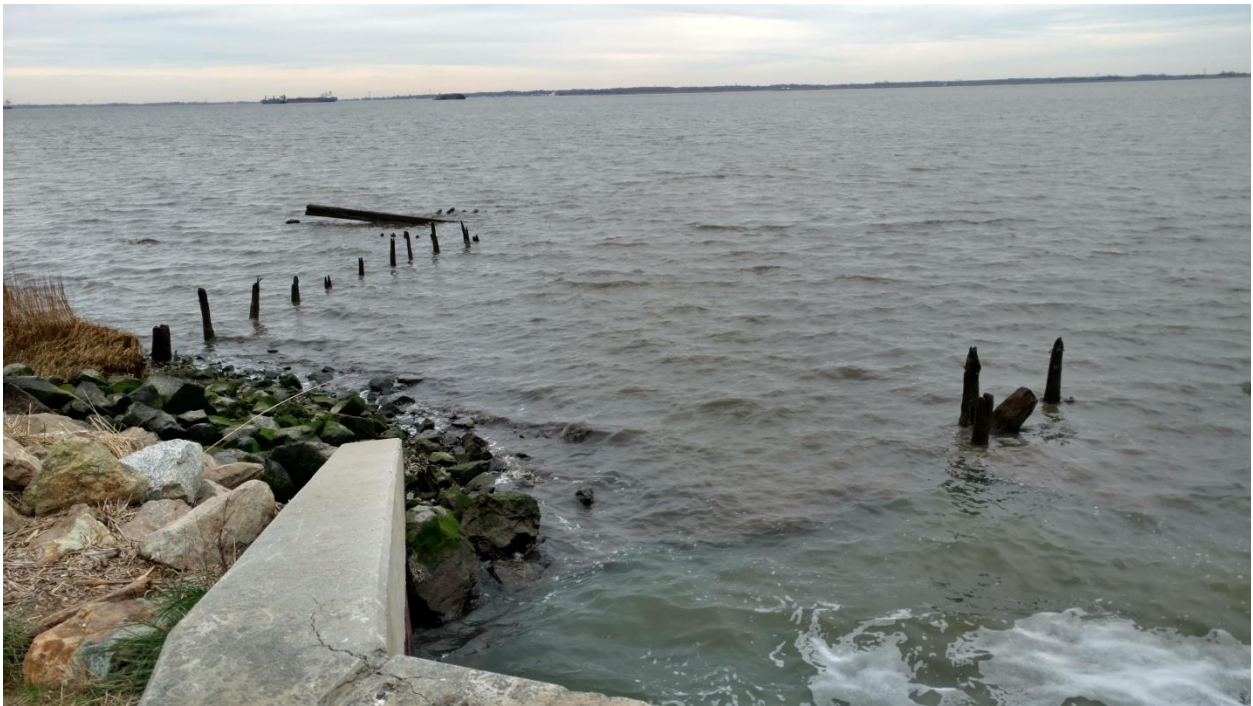
Figure 27. View to the east toward the river, showing the timber configuration north of the sluice.
